Site #66

113 W. Bridge
Granbury
Hood County
Est. 1925

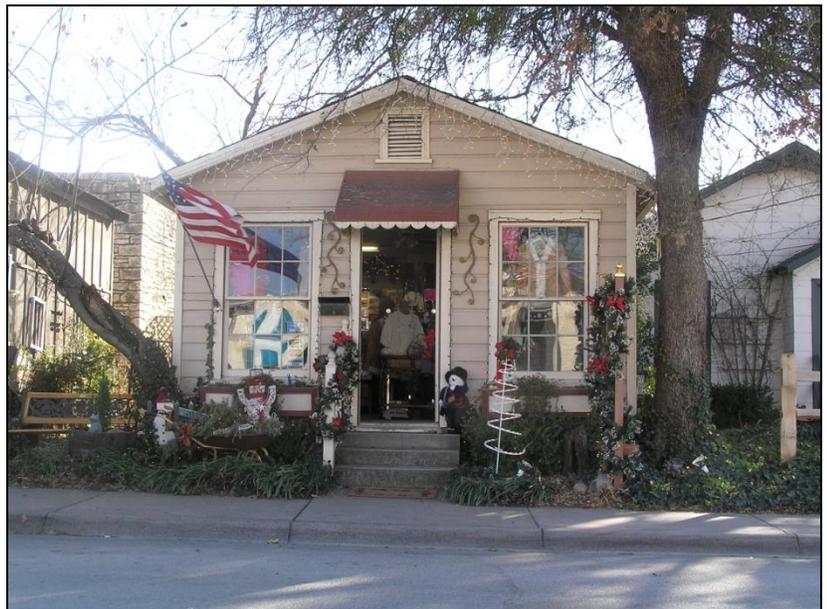
Photo Data: Roll/Frame M3/0

Location: Original Location

-Building faces north

-One story frame house

-Center passage plan

-Pier and Beam foundation

-Weatherboard siding

-Wood sash windows (6x6)

-Single door primary entrance

-Gable end treatments same as wall surface with vents

-Gable roof with composition shingles and exposed rafter ends

-Window or door on east side enclosed
