Site #148

528 N. Crockett

Granbury

Property Type: Vernacular House

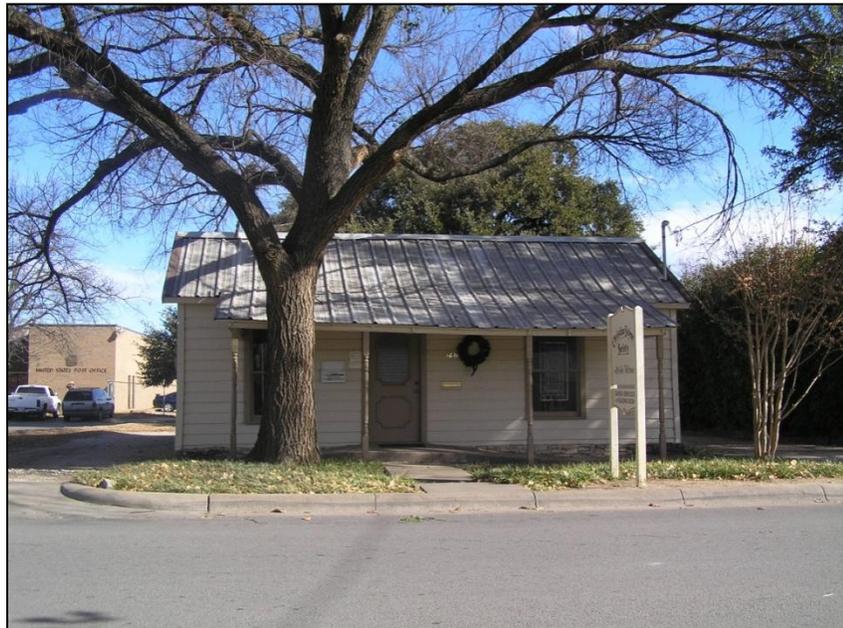
Photo Data: Roll/Frame M4/6

-Building faces west

-One story frame structure

-Center passage plan (one room deep)

-Pier and beam foundation

-Weatherboard siding (front), Synthetic siding (sides)

-Three bay, west elevation porch with shed roof and turned wood posts

-Wood sash, double hung windows (1/1)

-Single door primary entrance

-Gable end treatments same as wall surface with vents

-Gable roof with tin sheeting and box eaves (front)
