SURVEY OF HISTORIC RESOURCES  
North Side of City

GRANBURY, TEXAS

2008

**Individual Inventory Sheets for Property Nos. 1-60**

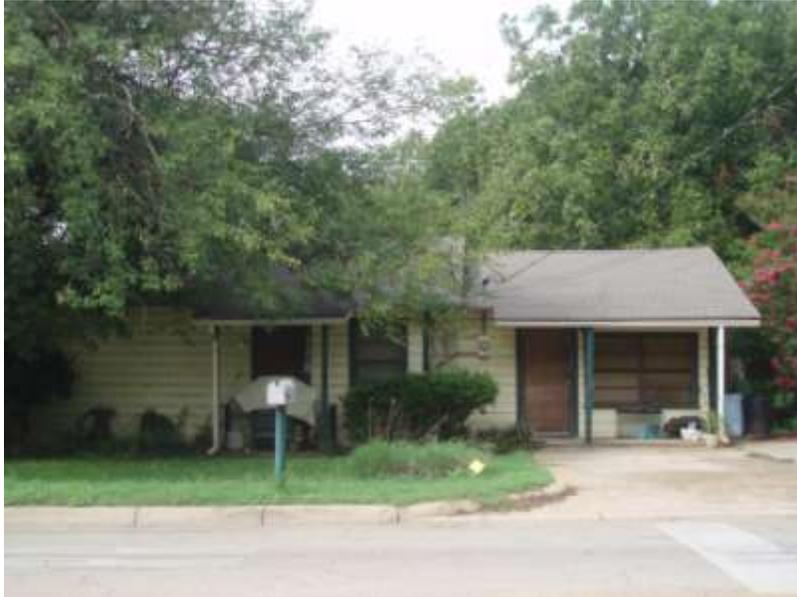
Property No.: **1**  
**615 Thorp Spring**

Frame construction, wood siding  
Gable roof, composition shingles  
Double-hung aluminum windows  
Two single primary entrances  
Shed roof porch with wood posts  
Center passage plan  
Pier-and-beam foundation  
One story, 468 square feet  
Carport or garage enclosed on north end, creating 280 additional square feet

**Location, setting, feeling, association**

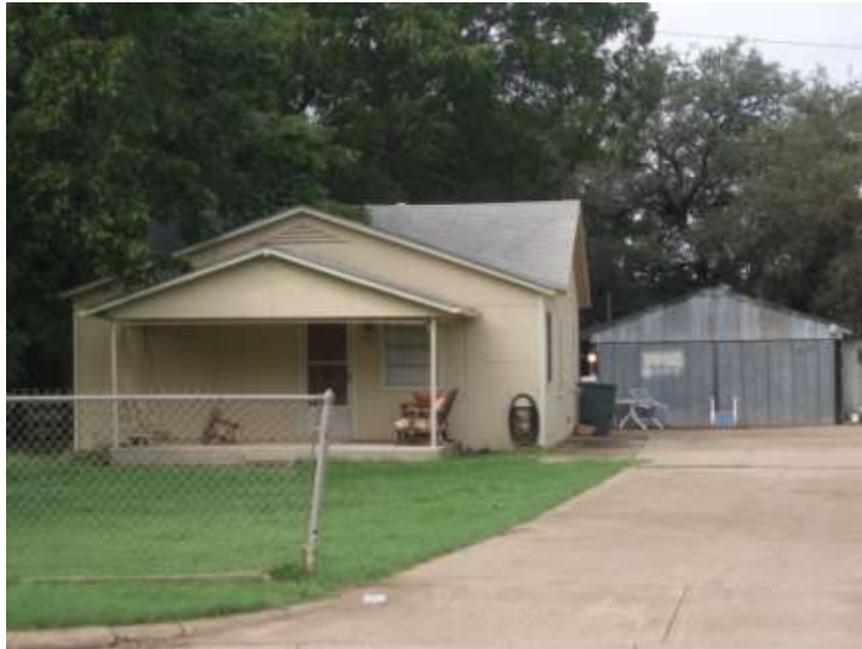
Frame construction, asbestos siding  
Gable roof, composition shingles  
Double-hung aluminum windows  
Single-door primary entrance  
Gable roof porch with painted steel pipe posts  
Bungalow, T-plan  
Pier-and-beam foundation  
One story, 624 square feet  
Enclosed porch and added porch in front

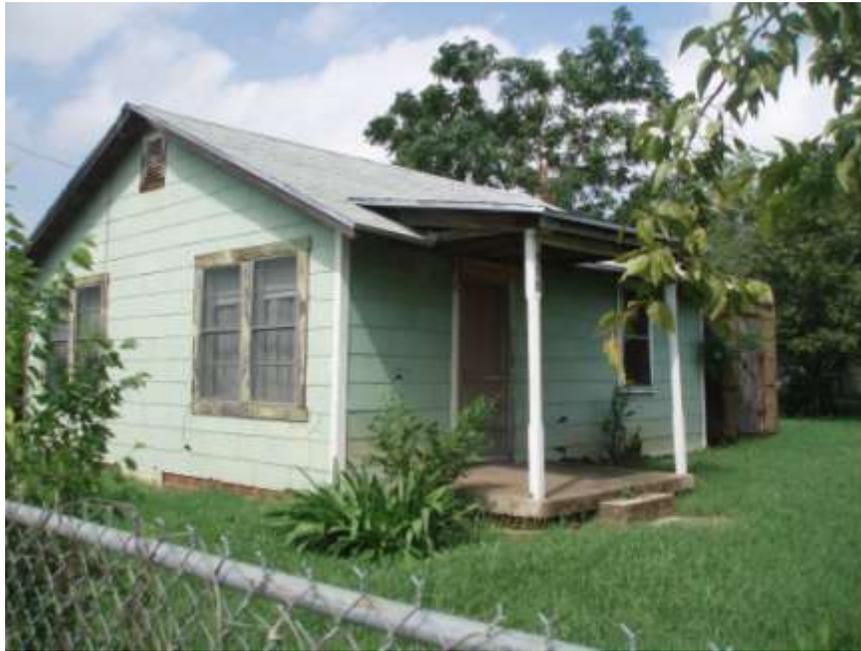
Frame construction, asbestos siding  
Gable roof, composition shingles  
Double-hung aluminum windows  
Single-door primary entrance  
Shed roof porch with wood posts  
Center passage plan  
Pier-and-beam foundation  
One story, 697 square feet  
Vacant, for sale along with 723 Thorp Spring

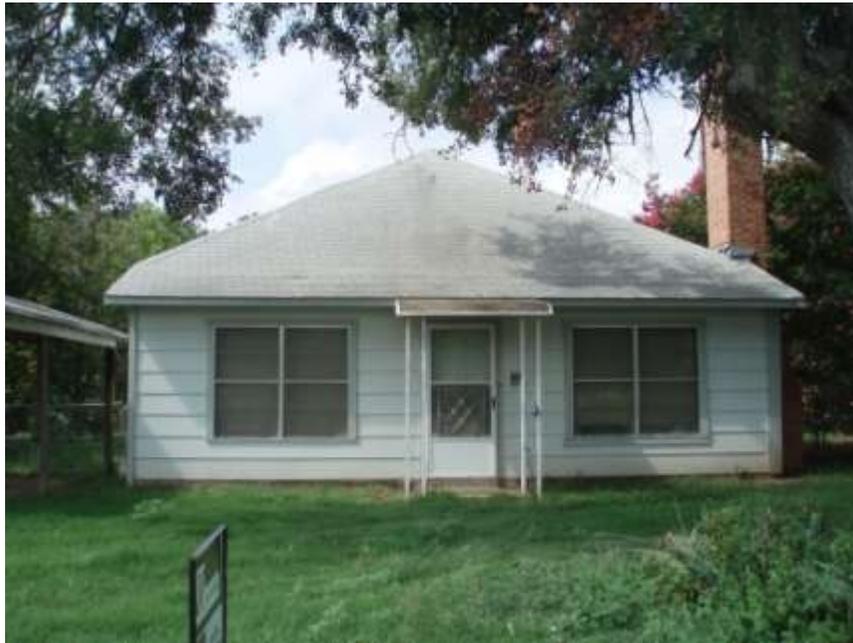
Frame construction, Hardie plank siding  
Hipped roof, composition shingles  
One exterior tall brick chimney on north end  
Double-hung aluminum windows  
Single-door primary entrance  
Shed roof porch with fabricated metal posts  
Four square plan with addition  
Pier-and-beam foundation  
One story, 1,469 square feet  
For sale along with 717 Thorp Spring and four acres for development

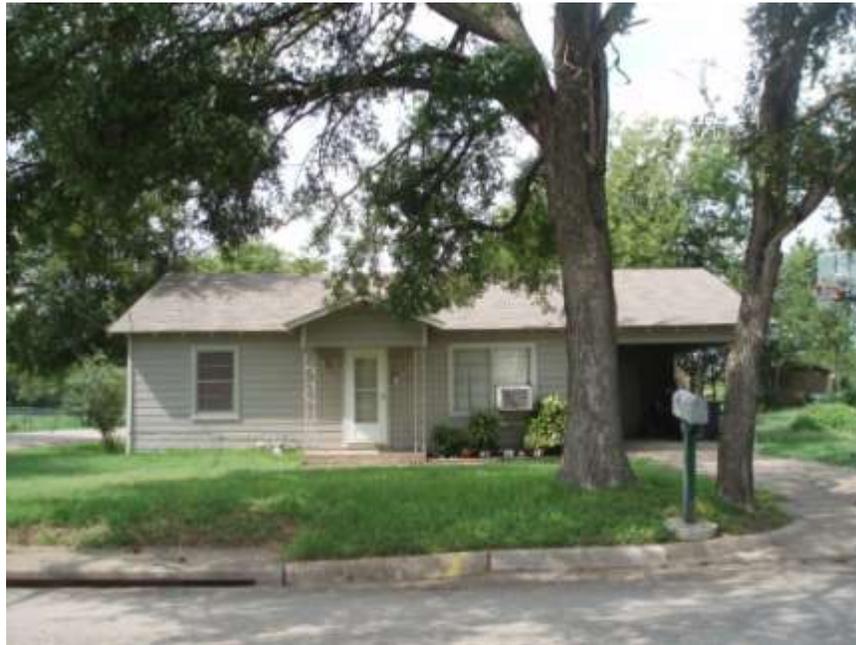
Frame construction, wood siding  
Gable roof, composition shingles, exposed rafter tails  
Double-hung aluminum windows  
Single-door primary entrance  
Gable roof porch with fabricated metal posts  
Center passage plan  
Pier-and-beam foundation  
One story, 990 square feet

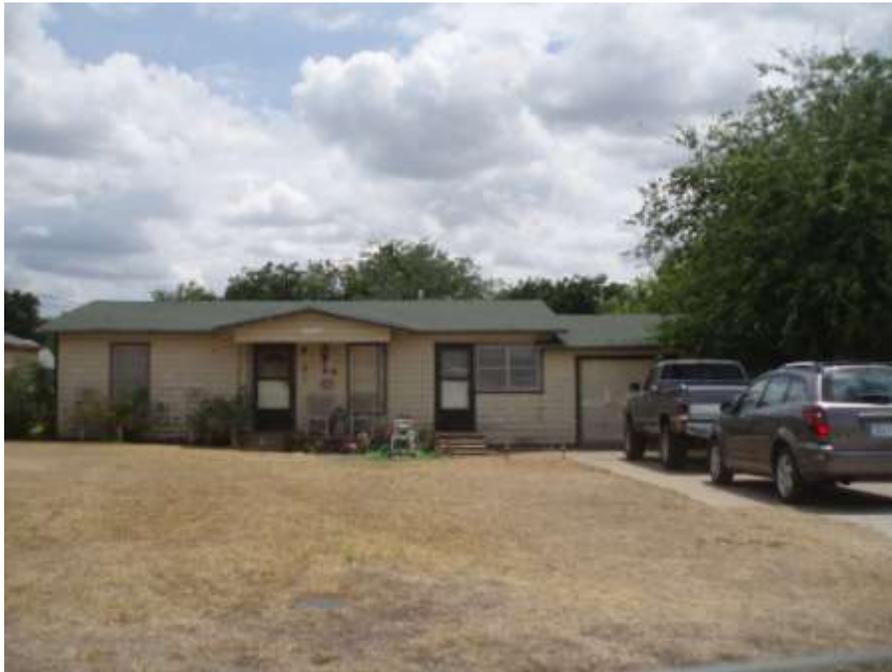
Frame construction, wood siding  
Gable roof, composition shingles  
One exterior tall brick chimney on north end  
Double-hung wood and aluminum windows  
Two single-door primary entrances  
Gable roof porch with fabricated metal posts  
Center passage plan  
Pier-and-beam foundation  
One story, 1,040 square feet  
Enclosed garage and added garage on west end

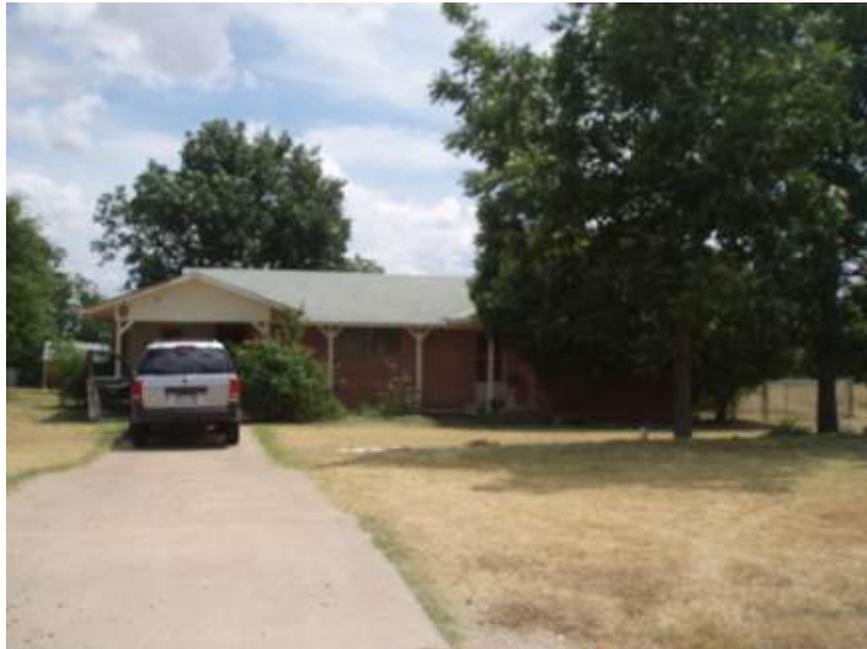
Frame construction, Brick veneer  
Gable roof, composition shingles  
One exterior tall brick chimney on north end  
Aluminum windows  
Single-door primary entrance  
Gable roof porch with wood posts  
L-plan  
Pier-and-beam foundation  
One story, 1,254 square feet  
Carport and brick exterior added to National Folk Hall and Parlor House to create Ranch-style House circa 1968

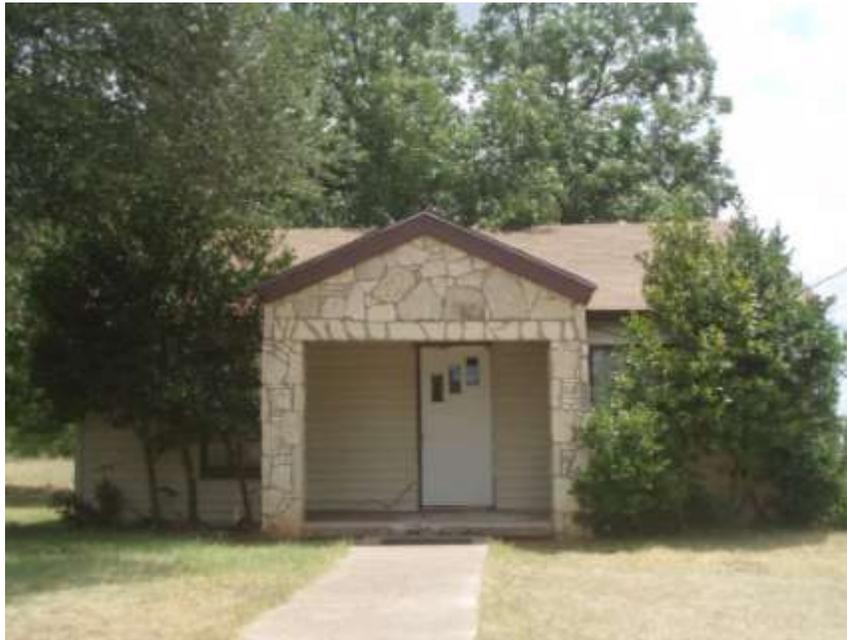
Frame construction, vinyl siding  
Gable roof, composition shingles  
Double-hung aluminum windows  
Single-door primary entrance  
Gable roof porch, random pattern limestone supports  
Center passage plan  
Pier-and-beam foundation  
One story, 868 square feet  
Folk limestone stonework added to porch

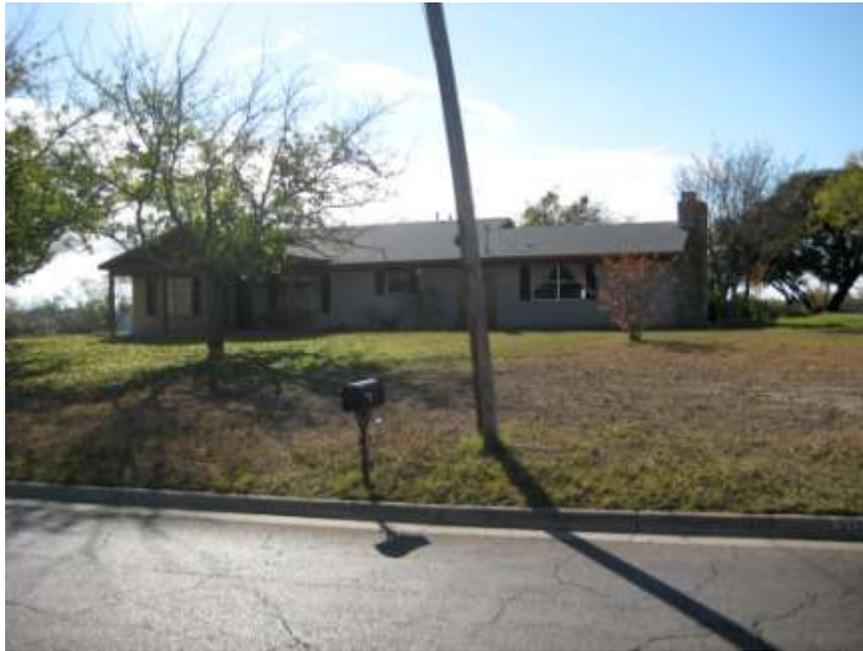
Brick Construction  
Gable roof, composition shingles  
One exterior stone chimney on north end  
Casement, aluminum windows with decorative shutters  
Single-door primary entrance  
Gable roof porch, wood posts  
Modified L- plan  
Slab foundation  
One story, 2,182 square feet  
Front porch added 2007

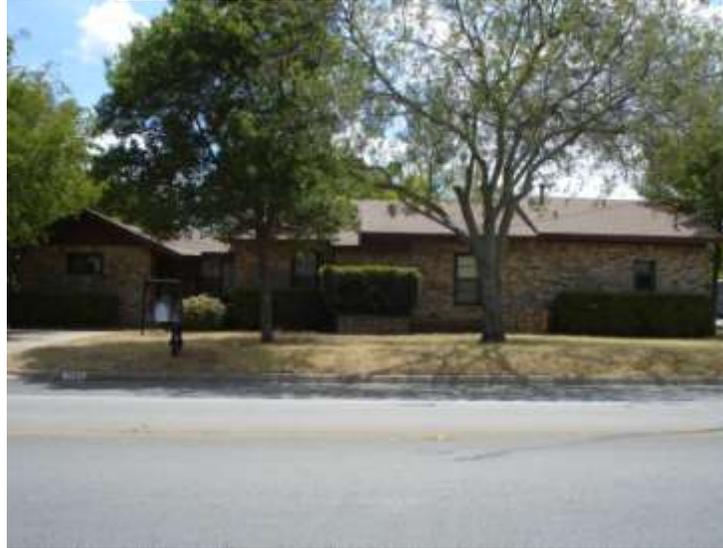
Frame construction, brick veneer  
Gable roof, composition shingles  
Double-hung, aluminum windows  
Single-door primary entrance  
Inset stoop  
Rectangular, T-plan  
Slab foundation  
One story, 2,010 square feet  
Built-in brick planters in front  
Additions to rear of rectangular house create T-plan

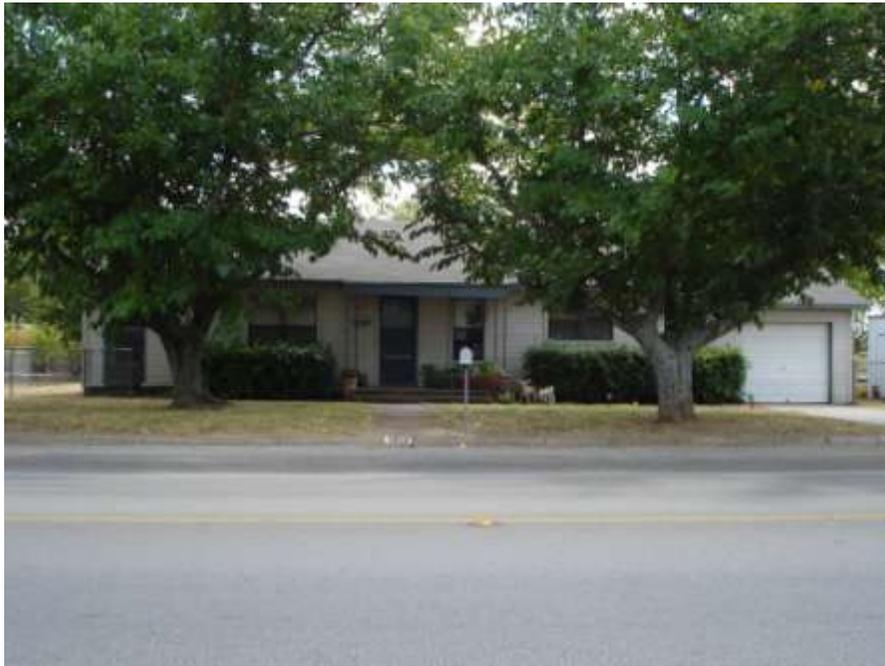
Frame construction, vinyl siding  
Gable roof, composition shingles  
Double-hung, aluminum windows  
Single-door primary entrance  
Shed roof porch, fabricated metal supports  
Center passage  
Pier and beam foundation  
One story, 1,350 square feet  
Carport added on west end, room added on east end

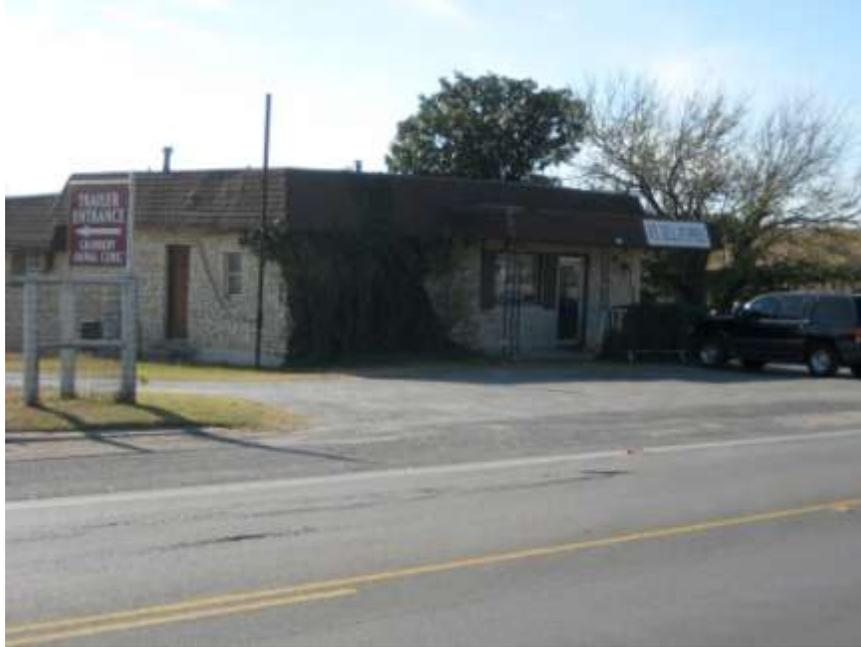
Frame construction, limestone veneer  
Flat mansard roof, composition shingles  
Fixed aluminum windows  
Single-door primary entrance  
Shed roof porch, fabricated metal supports  
Square plan  
Slab foundation  
One story  
Carport added on west end, room added on east end

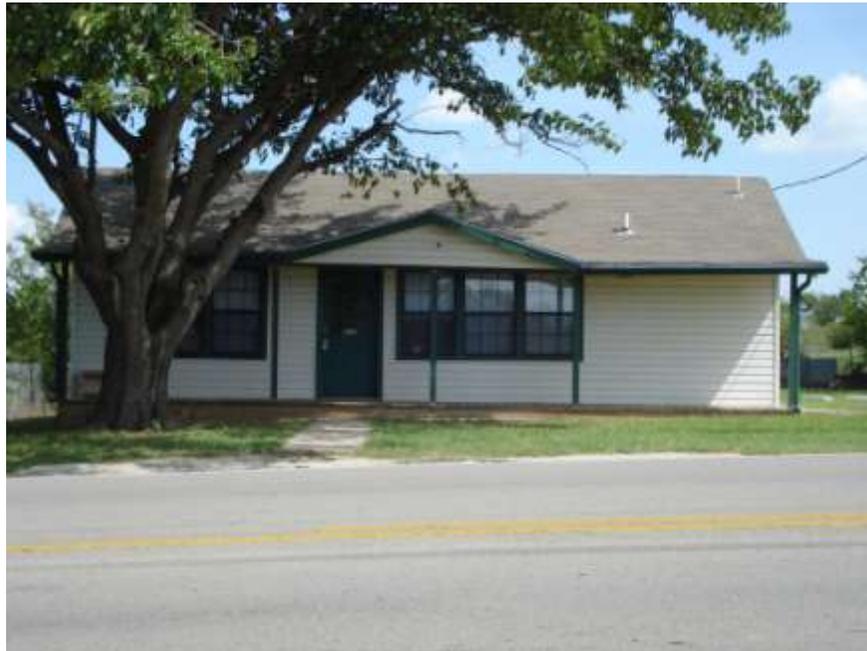
Frame construction, vinyl siding  
Gable roof, composition shingles  
Double-hung, aluminum windows  
Single-door primary entrance  
Gable roof porch  
Center passage plan  
Pier and beam foundation  
One story, 1,005 square feet  
Additions on east end and north elevation

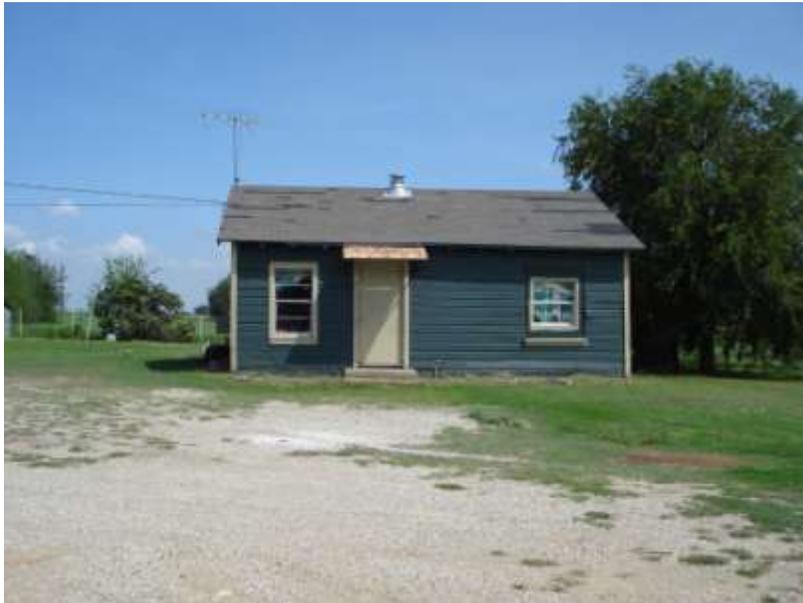
Frame construction, wood siding  
Gable roof, composition shingles  
Double-hung, aluminum and vinyl windows  
Single-door primary entrance  
Center passage plan  
Pier and beam foundation  
One story, 528 square feet

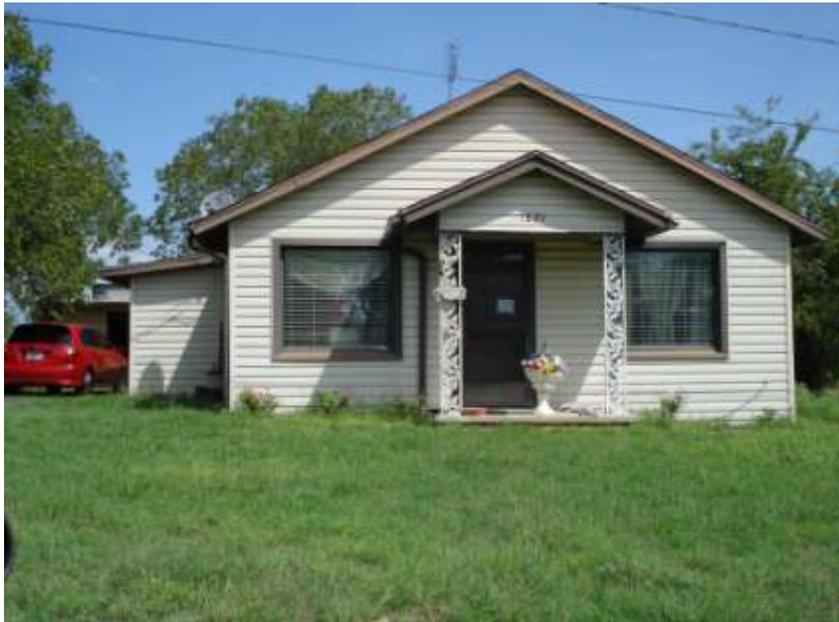
Frame construction, vinyl siding  
Gable roof, composition shingles  
Fixed aluminum windows  
Single-door primary entrance  
Gable roof porch, fabricated metal supports  
Bungalow plan  
Pier and beam foundation  
One story, 708 square feet

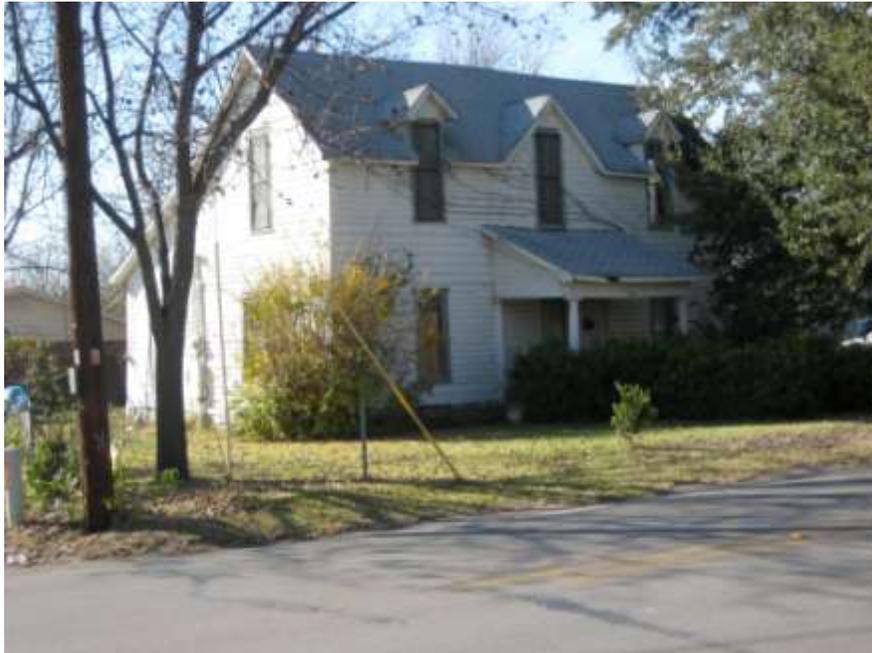
Frame construction, wood siding  
Gable roof, composition shingles, gable dormers  
Three bays  
Double-hung, wood windows  
Single-door primary entrance  
Shed roof porch, classical columns and pilasters  
I-house plan  
Pier and beam foundation  
Two stories, 1,330 square feet

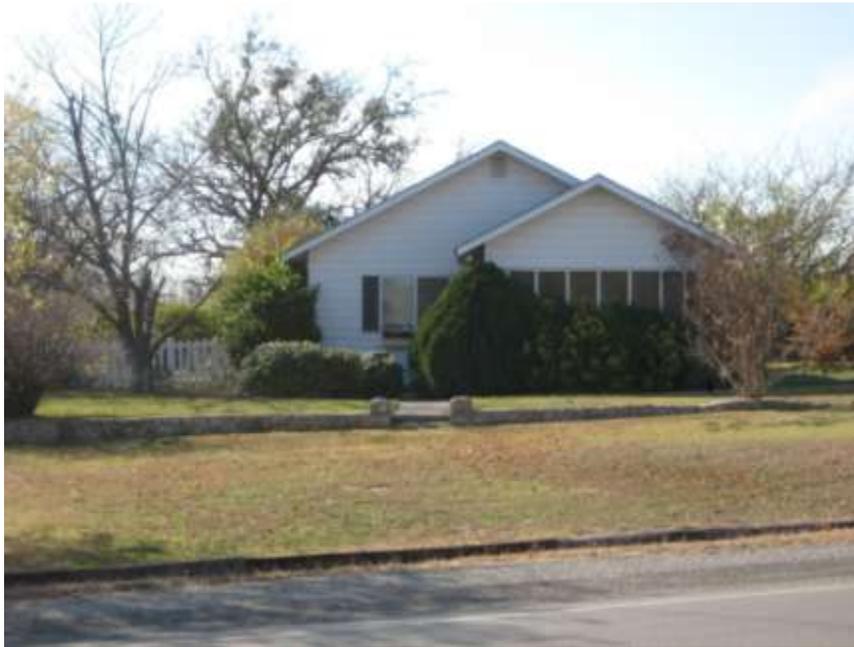
Frame construction, vinyl siding  
Gable roof, composition shingles  
Fixed or casement, aluminum windows  
Gable roof porch enclosed and screened  
Bungalow plan  
Pier and beam foundation  
One story, 1404 square feet  
Rooms added to rear

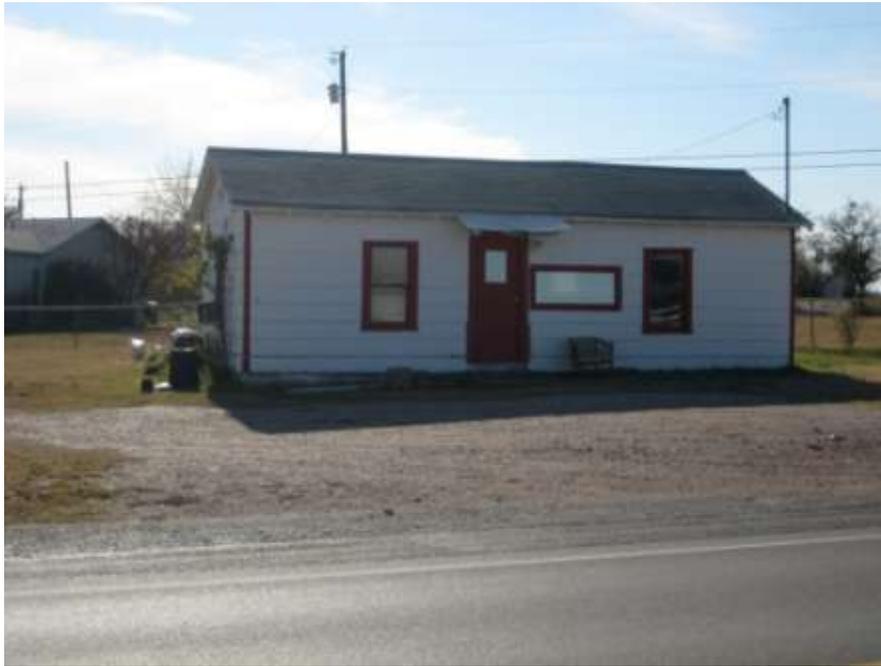
Frame construction, asbestos siding  
Gable roof, composition shingles, exposed rafter tails  
Double-hung, wood windows  
Single-door primary entrance  
Center passage plan  
Pier and beam foundation  
One story, 512 square feet

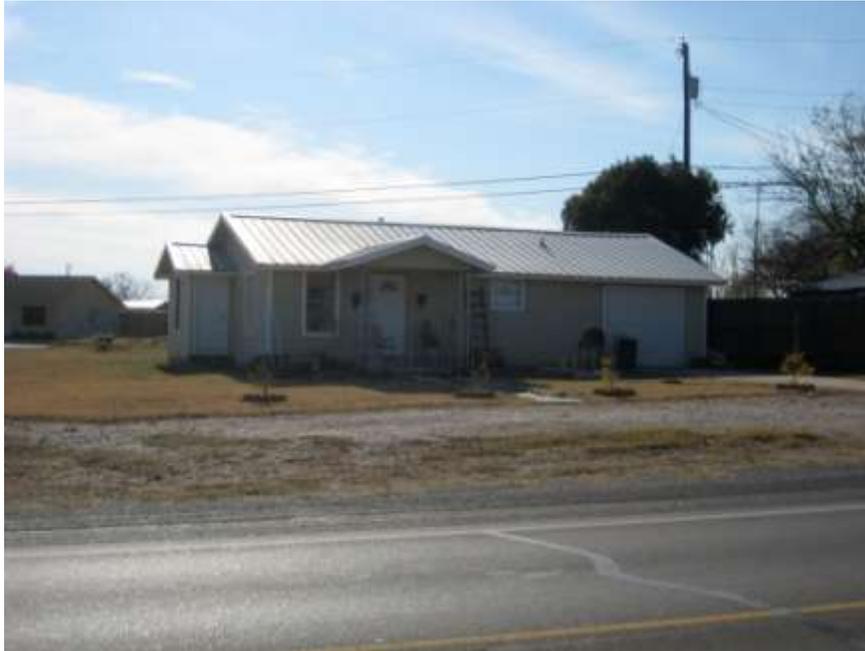
Frame construction, wood siding  
Gable roof, metal  
Double-hung, aluminum windows  
Gable roof porch, fabricated metal supports  
L-plan  
Pier and beam foundation  
One story, 990 square feet

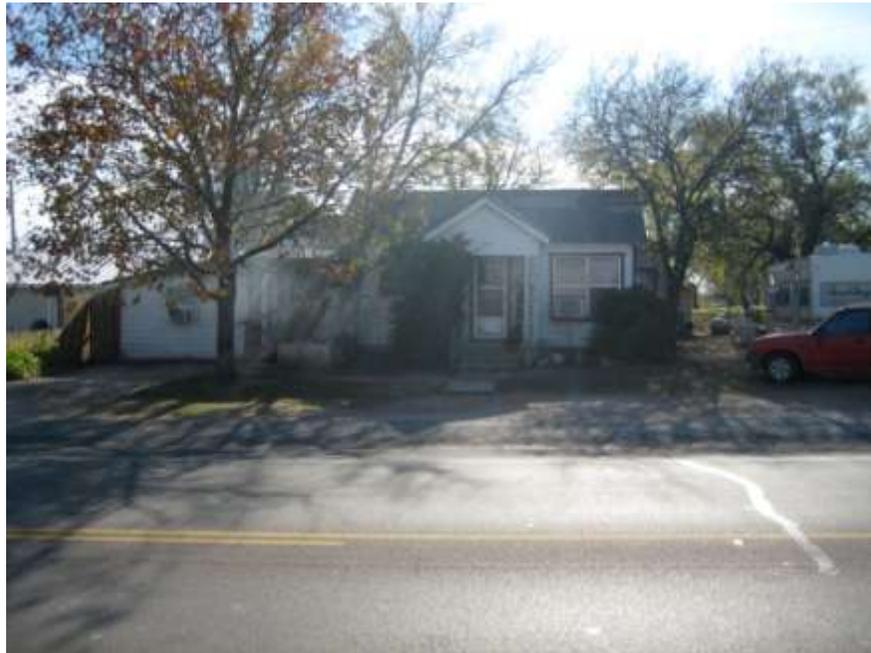
Frame construction, wood siding  
Gable roof, composition shingles, exposed rafter tails  
Double-hung, aluminum windows  
Gable roof porch, wood posts  
Center passage plan  
Pier and beam foundation  
One story, 1,000 square feet  
Corner lot  
Shed room addition on east end, ell addition to south or rear

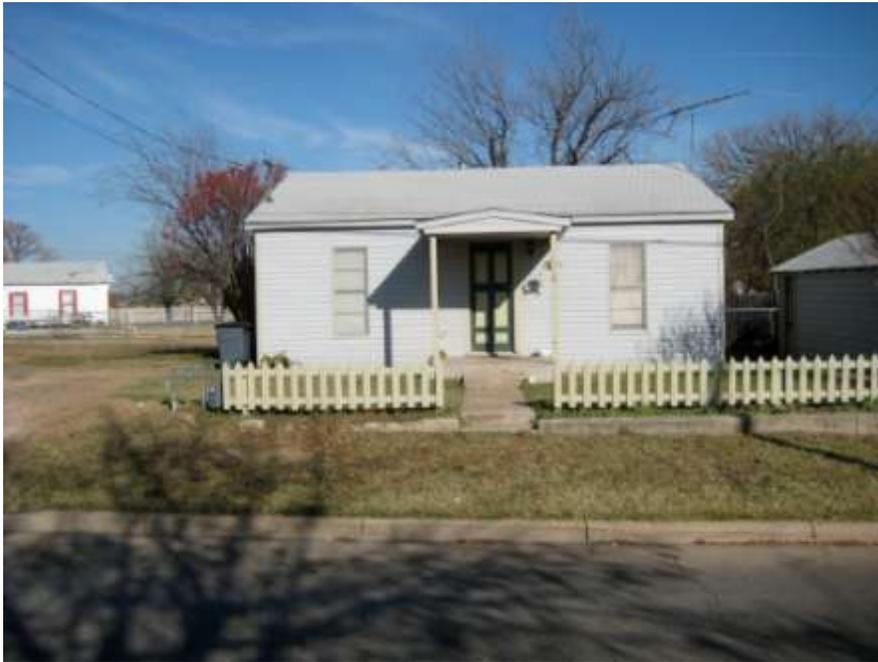
Frame construction, aluminum siding  
Gable roof, composition shingles  
Double-hung, aluminum windows  
Single-door primary entrance  
Gable roof porch, wood posts  
Center passage plan  
Pier and beam foundation  
One story, 920 square feet

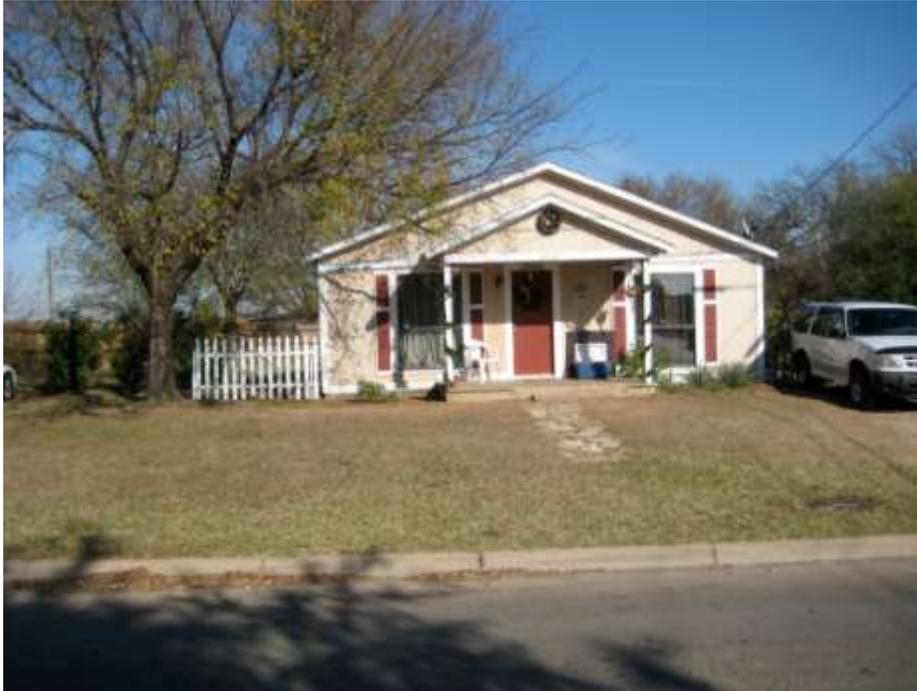
Frame construction, vertical wood siding  
Gable roof, composition shingles  
Double-hung, aluminum windows, decorative shutters  
Single-door primary entrance  
Gable roof porch, wood posts  
Bungalow plan  
Pier and beam foundation  
One story, 1,036 square feet

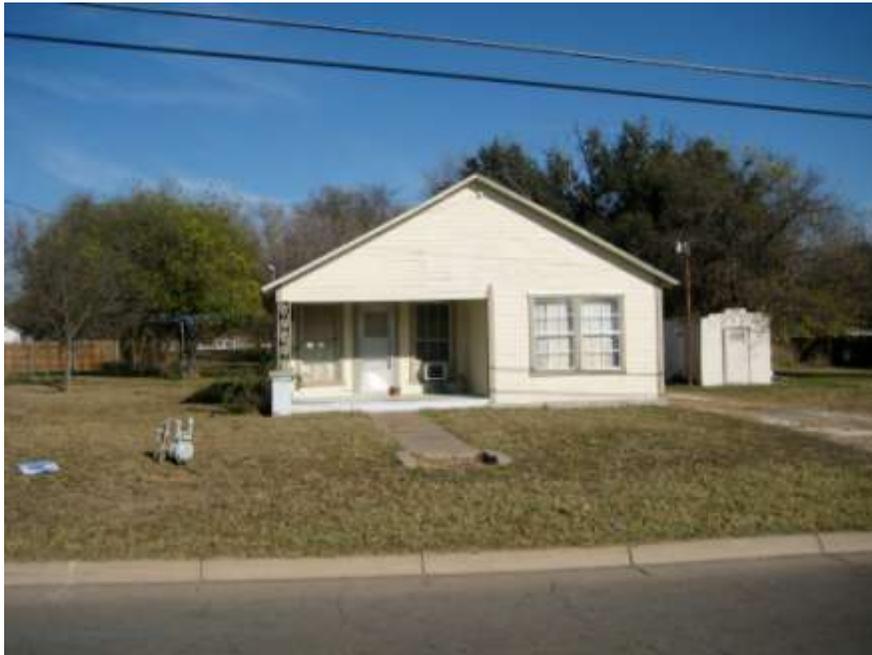
Frame construction, wood siding  
Gable roof, composition shingles, exposed rafter tails  
Double-hung, wood and aluminum windows  
inset porch, fabricated metal support  
Bungalow plan  
Pier and beam foundation  
One story, 968 square feet

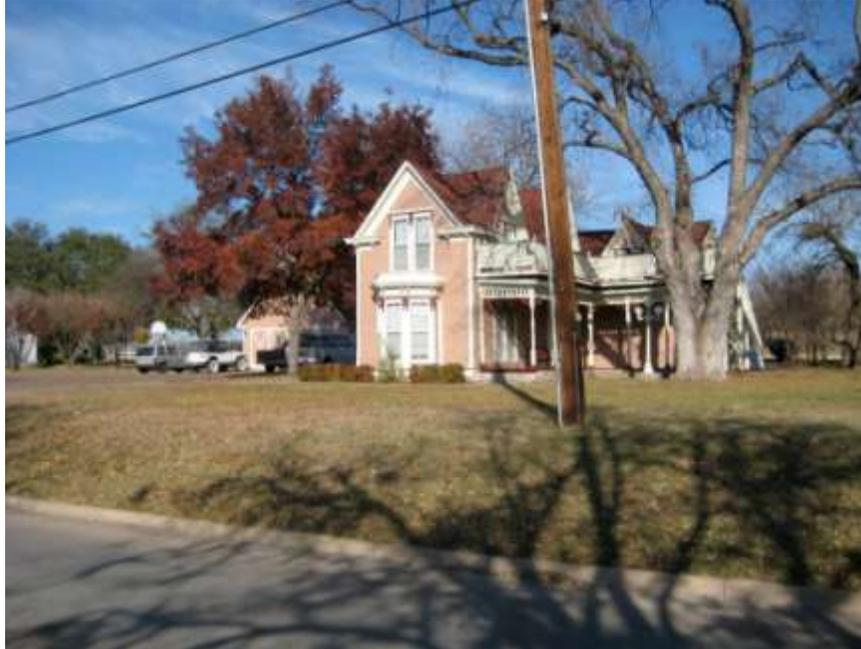
Frame construction, wood siding  
Gable roof, composition shingles, gable dormers  
One exterior stone chimney  
Double-hung, wood windows, large 3-bay in front with bracketed cornice  
Single-door primary entrance with transom  
Shed roof porch, turned wood posts, spindlework, jig-sawn trim, second-floor balcony and balustrade  
L-plan, Pier and beam foundation  
Two stories, 1,987 square feet

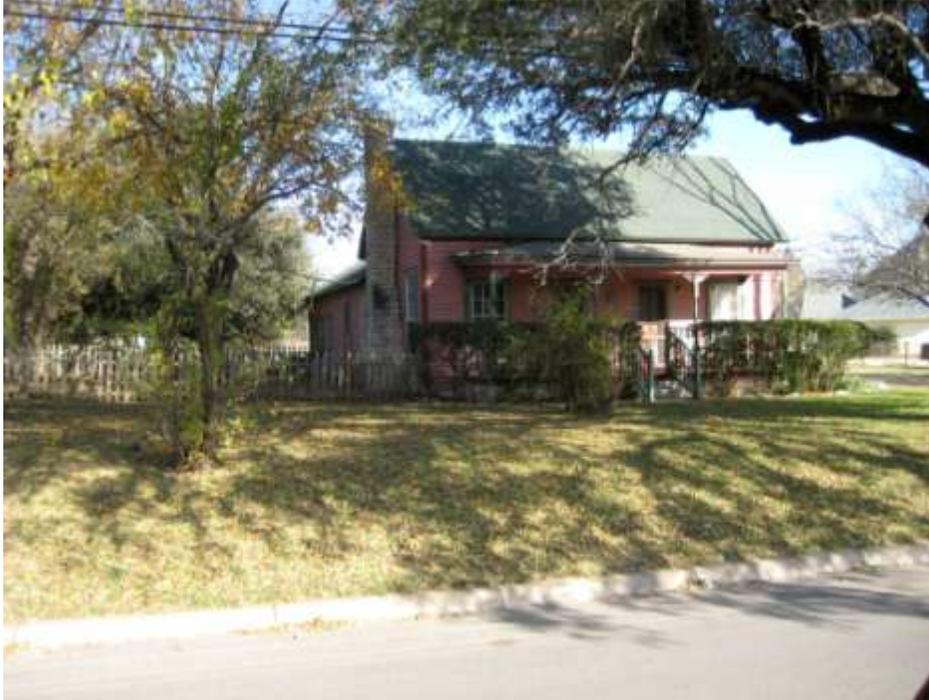
Frame construction, wood siding  
Gable roof, composition shingles  
One exterior stone chimney  
Double-hung, wood and vinyl windows  
Two single-door entrances  
Hipped roof porch, turned wood posts, jig-sawn trim  
Center passage, T-plan  
Pier and beam foundation

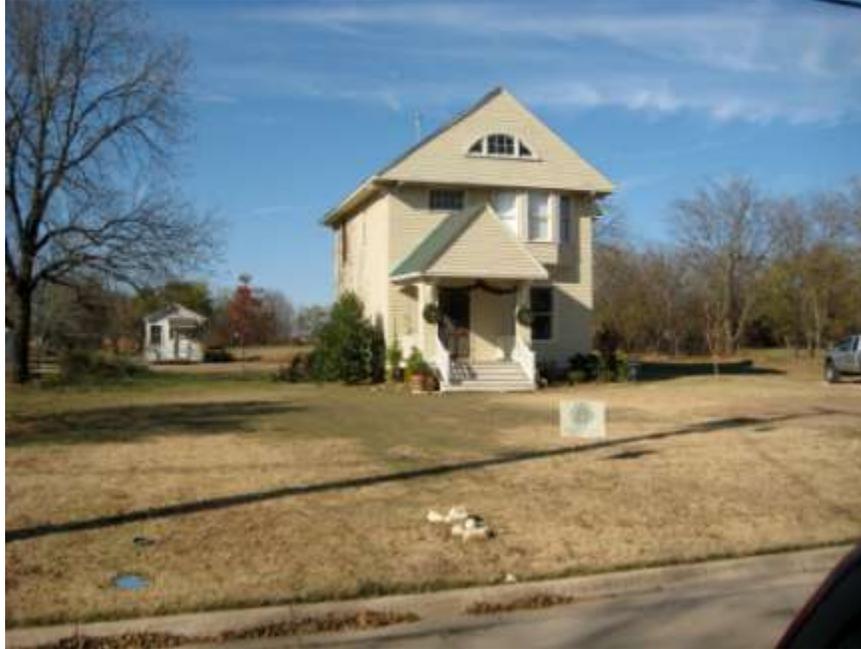
Frame construction, wood siding  
Gable roof, composition shingles, gable dormers  
Double-hung, wood windows, two fixed in front, projecting bay window and oriel window in front gable  
Single-door primary entrance  
Gable roof porch, box columns, knee-brace brackets  
L-plan, Pier and beam foundation  
Two and a half stories, 1,576 square feet

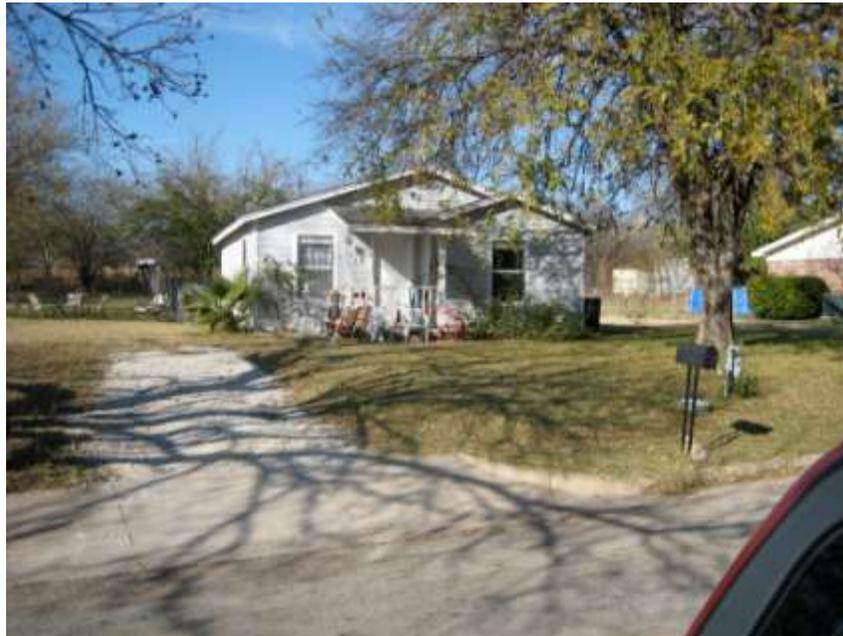
Frame construction, Hardie plank siding  
Gable roof, composition shingles  
Double-hung, wood windows  
Single door primary entrance  
Shed roof porch, box columns, balustrade  
Bungalow plan  
Pier and beam foundation  
One story, 754 square feet

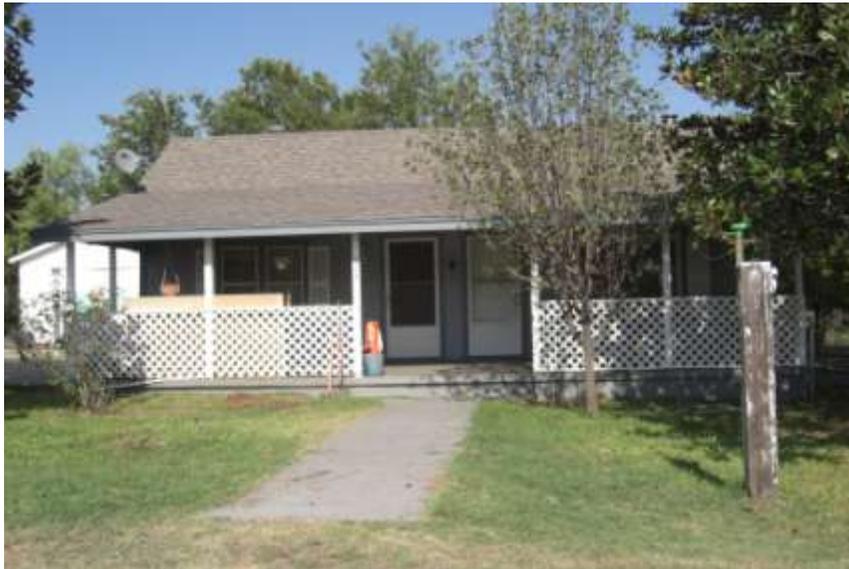
Frame construction, wood siding  
Gable roof, composition shingles  
Double-hung, wood windows, decorative shutters  
Two single door primary entrances  
Shed roof porch, wood posts  
Center passage plan  
Pier and beam foundation  
One story, 1,258 square feet  
Shed addition in rear

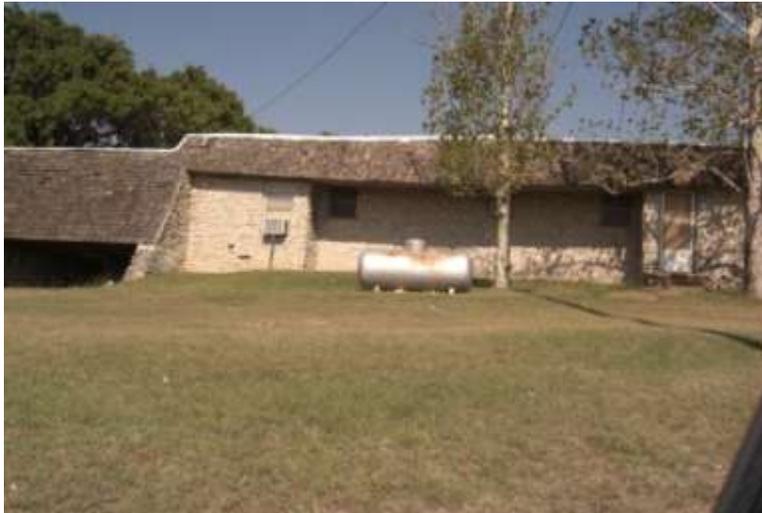
Frame construction, limestone veneer  
Flat roof, mansard, wood shingles  
One exterior stone chimney  
Double-hung, aluminum windows  
Single door primary entrances  
Inset porch  
Rectangular plan  
Pier and beam foundation  
One story, 2,386 square feet  
Shed addition in rear  
Garage on north end below grade or built into hillside, Addition to east elevation or rear, apparently originally built as frame house and limestone added

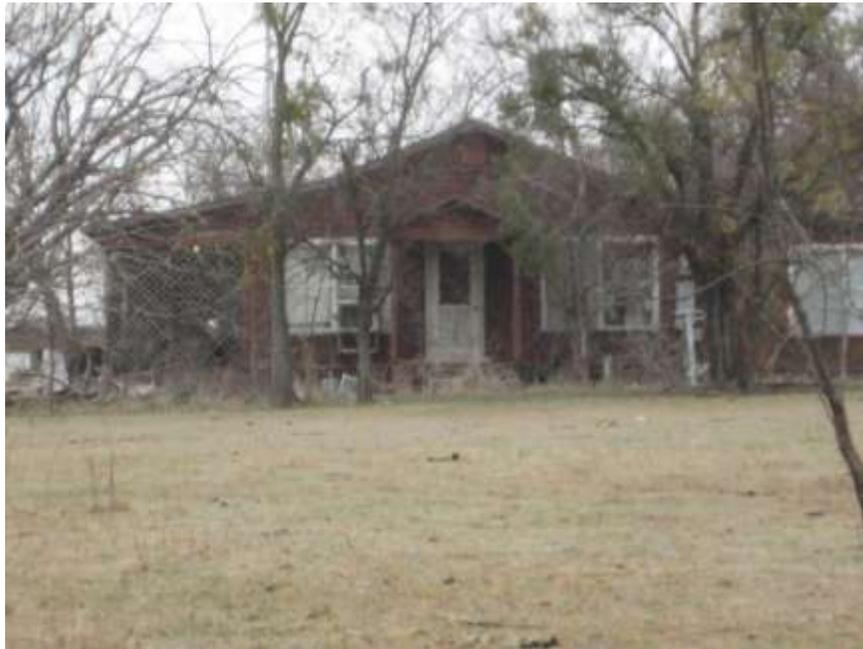
Frame construction, vertical wood siding  
Gable roof, composition shingles  
Double-hung, aluminum windows  
Single door primary entrance  
Gable roof porch, wood posts  
Center passage plan  
Pier and beam foundation  
One story, 1,356 square feet  
Rooms added to rear  
Large lot—almost 7 acres—lots of old cars, deep setback and long drive, large barn to northwest, three sheds

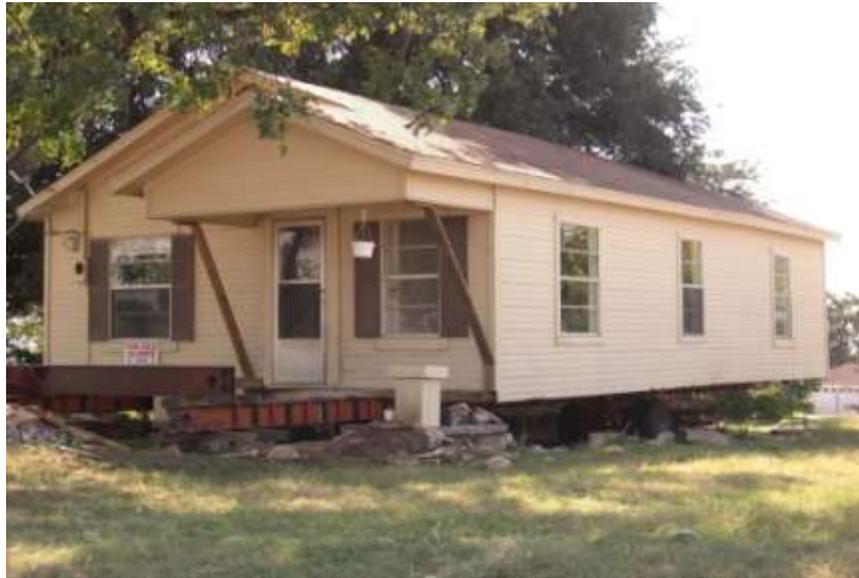
Frame construction, vinyl siding  
Gable roof, composition shingles  
Double-hung, aluminum windows  
Single-door primary entrance  
Gable roof porch  
Bungalow plan  
Pier and beam foundation

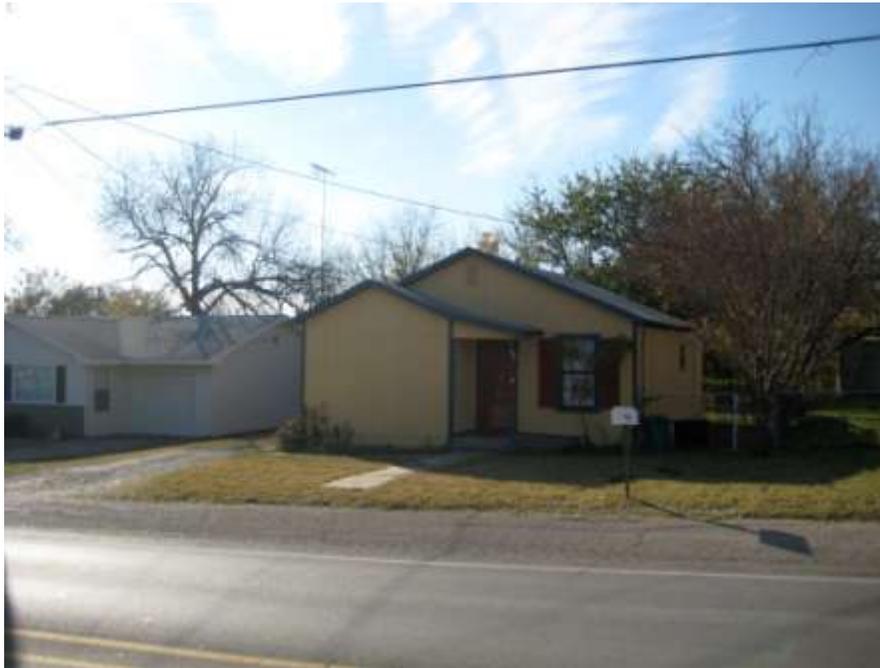
Frame construction, vertical wood siding  
Gable roof, composition shingles, exposed rafter tails  
Wood sash and aluminum sash windows decorative shutters  
Single door primary entrance  
Shed roof porch, turned wood posts, south three-fourths enclosed  
Bungalow plan  
Pier and beam foundation  
One story, 832 square feet  
Single car garage added on north end

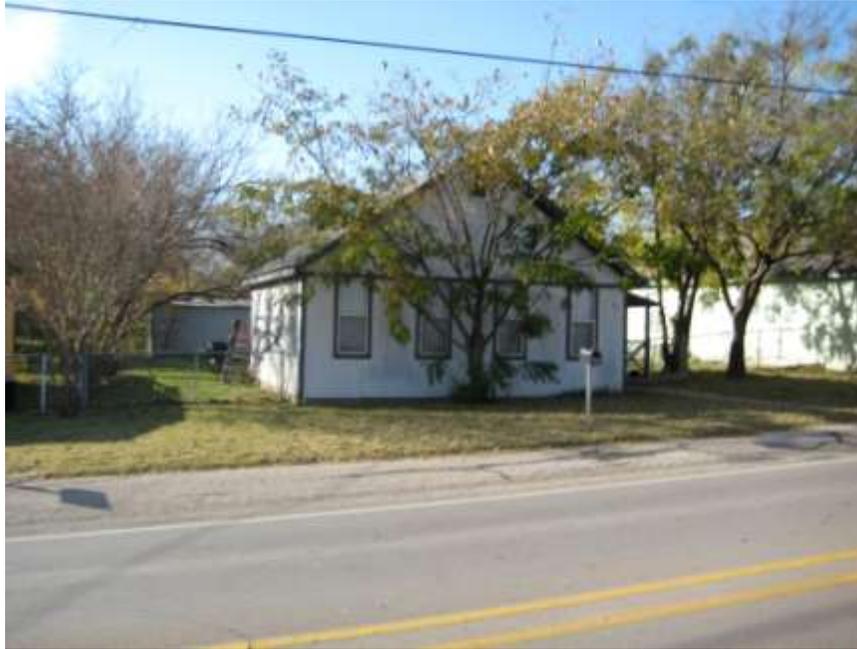
Frame construction, stucco  
Gable roof, composition shingles  
Double-hung, aluminum windows  
Single-door primary entrance  
Shed roof porch, wood posts  
Central passage plan  
Pier and beam foundation  
One story, 504 square feet  
Entrance faces north rather than east toward street

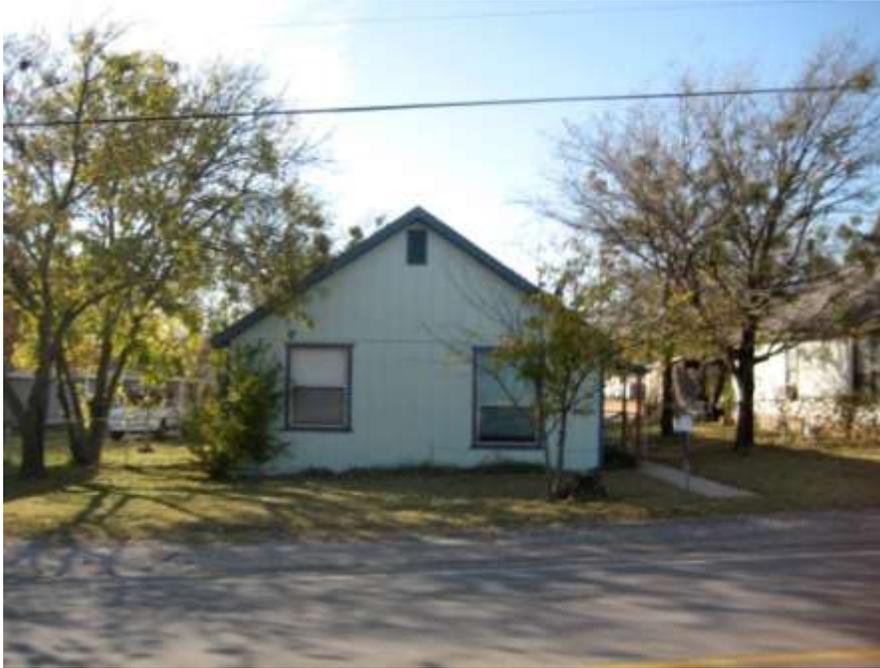
Frame construction, vertical wood siding  
Gable roof, composition shingles  
Double-hung, aluminum windows  
Single-door primary entrance  
Shed roof porch, wood posts  
Central passage plan  
Pier and beam foundation  
One story, 1008 square feet  
Entrance faces north rather than east toward street

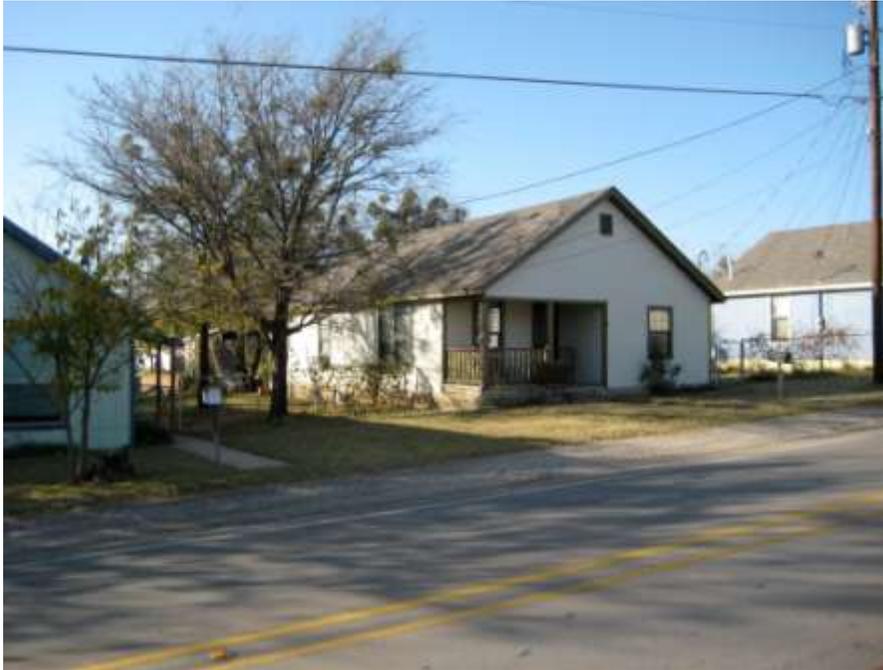
Frame construction, wood siding  
Gable roof, composition shingles  
Double-hung wood sash and aluminum sash windows  
Single door primary entrance  
Inset porch, box columns, balustrade  
Bungalow plan  
Pier and beam foundation  
One story, 504 square feet  
Additional 432 square feet added in 1996

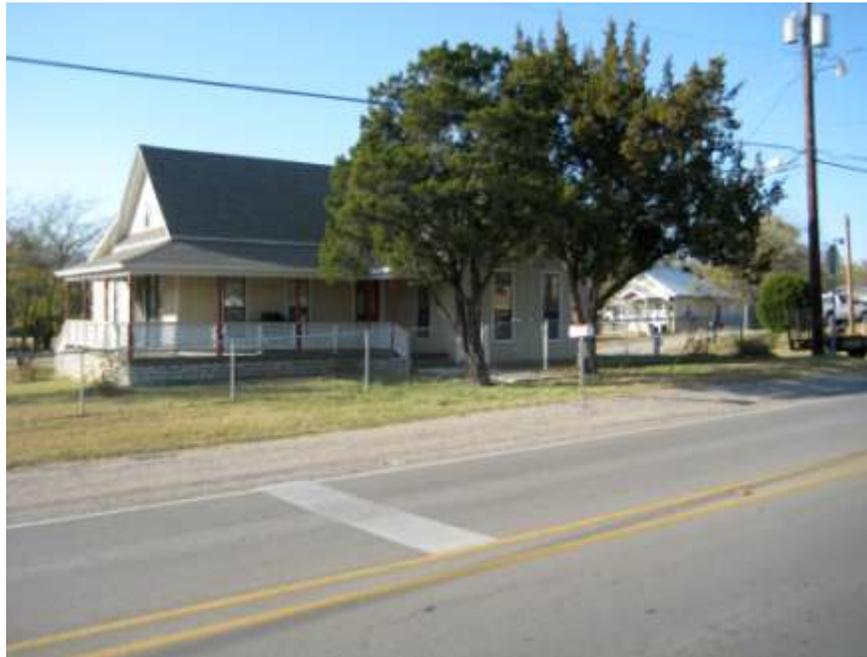
Frame construction, vertical wood siding  
Gable roof, composition shingles  
Double-hung, aluminum sash windows  
Single door primary entrance  
Shed roof porch, turned wood posts, wraparound  
L-plan with additions  
Pier and beam foundation  
One story, 1,186 square feet  
Sliding glass door added to south elevation
