SURVEY OF HISTORIC RESOURCES  
North Side of City

GRANBURY, TEXAS

2008

**Individual Inventory Sheets for Property Nos. 1-60**

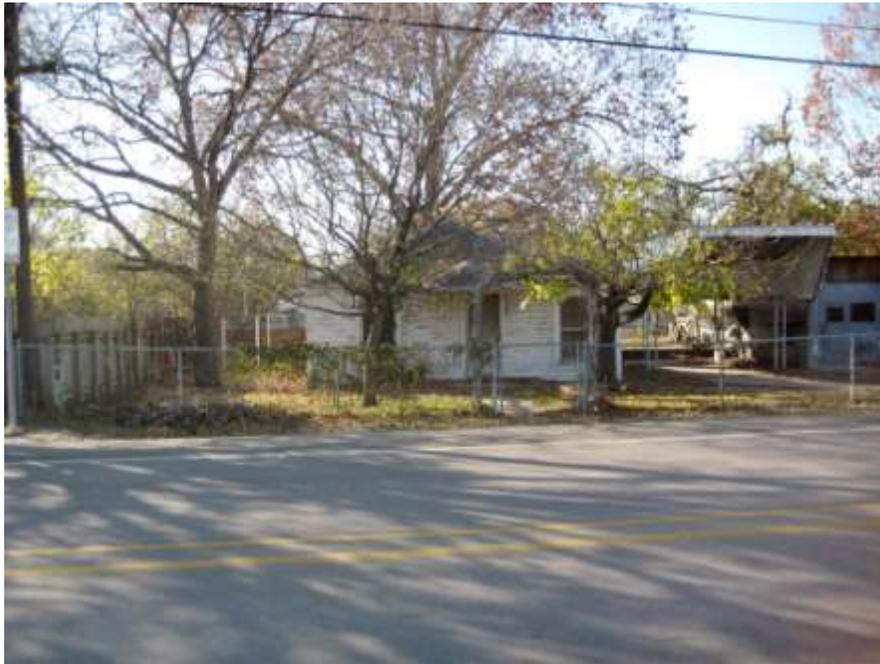
Frame construction, wood siding  
Hipped roof, composition shingles  
Double-hung, wood windows  
Single door primary entrance  
Hipped roof porch, brackets  
Four square plan  
Pier and beam foundation  
One story

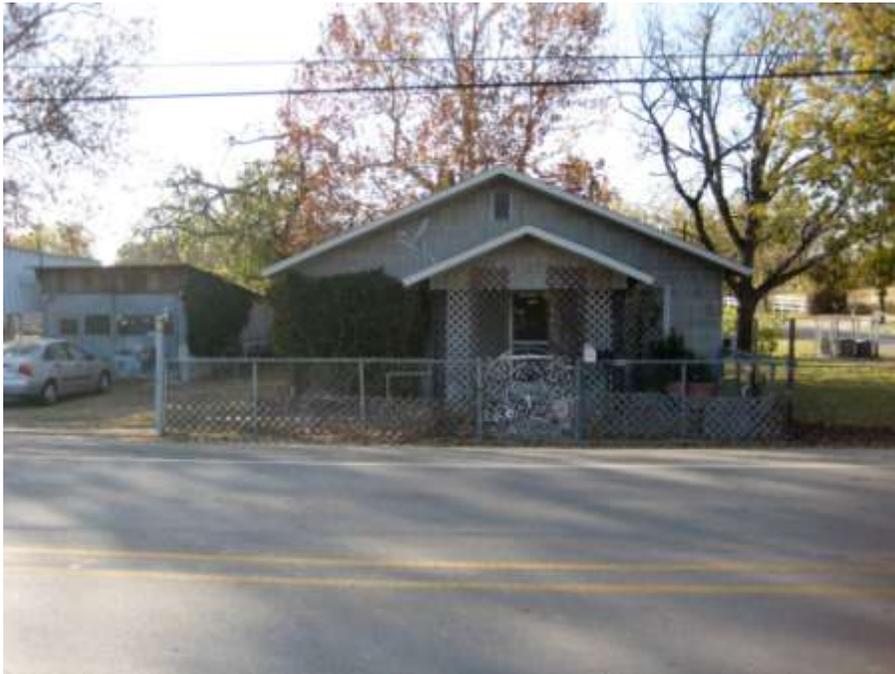
Frame construction, asbestos siding  
Gable roof, composition shingles  
Double-hung, wood windows  
Single door primary entrance  
Gable roof porch, fabricated metal supports  
Bungalow plan  
Pier and beam foundation  
One story, 780 square feet

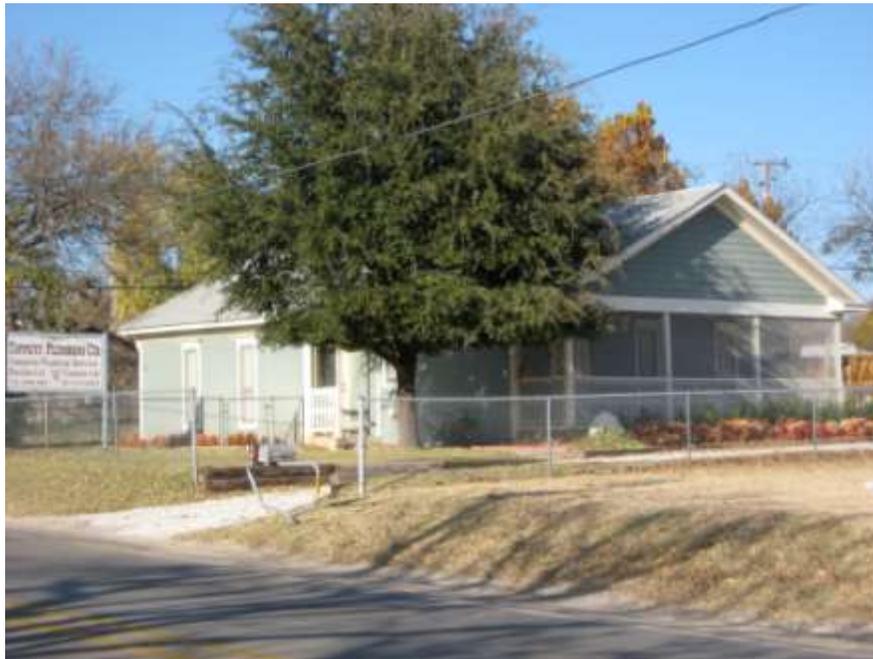
Original foundation, basement, and floor remain; rest of house rebuilt 2003 on same footprint only just a little larger

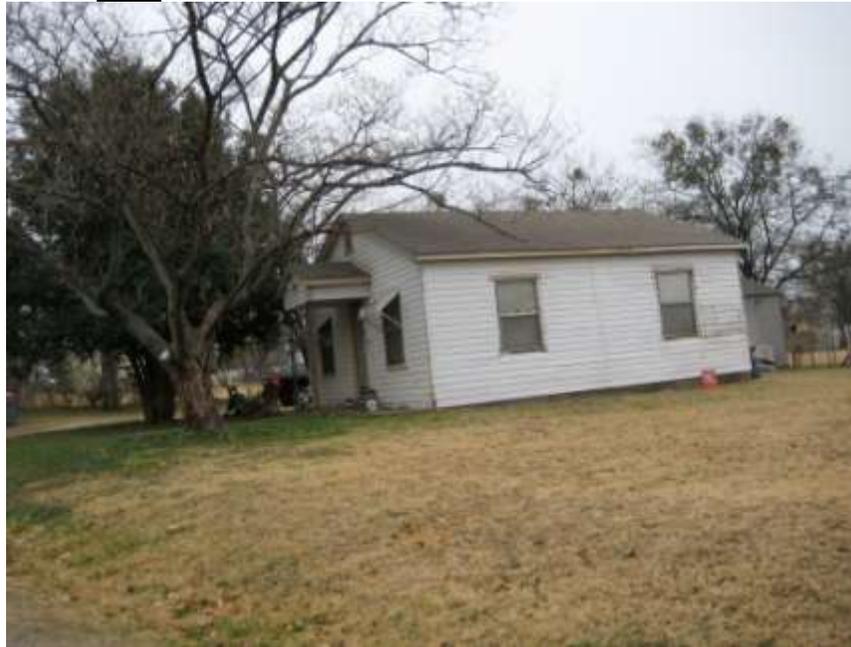
According to the owner, this is a Craftsman cottage with all-original materials, that has been well taken care of and is the original condition a when it was built during World War II.

Frame construction, wood siding  
Gable roof, composition shingles  
Double-hung, aluminum windows  
Single-door primary entrance  
Gable roof porch, fabricated metal supports  
Shotgun plan  
Pier and beam foundation  
One story, 576 square feet  
Entrance faces north rather than east toward street
