Site #25

411 W. Bluff

Granbury
Hood County
Est. 1945

Property Type: Vernacular House

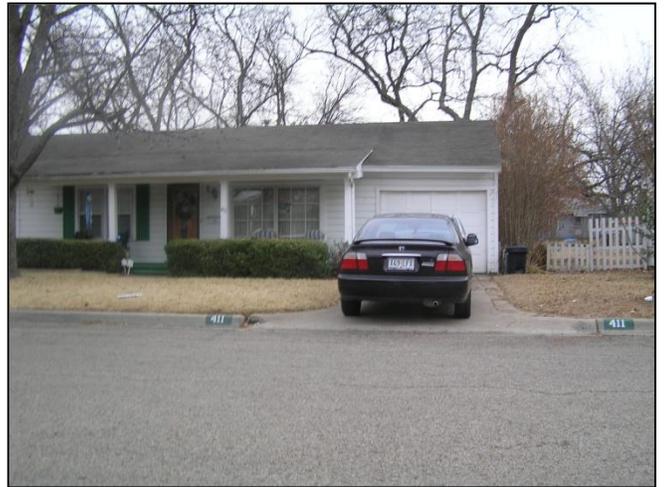
Photo Data: Roll/Frame D2/18

- Building faces north
- One story frame house
- Bungalow Plan
- Pier and Beam and Cement Foundation
- Weatherboard Siding Exterior Wall Surface
- Three north elevation porch with shed roof and full height tapered box supports
- Aluminum sash, double hung windows (Six over Six, fixed 2-12 light)
- Single door primary entrance
- Gable end treatments same as wall surface
- Gable roof with composition shingles and box eaves
