Site #52

100 N. Cleburne

Granbury
Hood County
Est. 1900

Property Type: Vernacular House

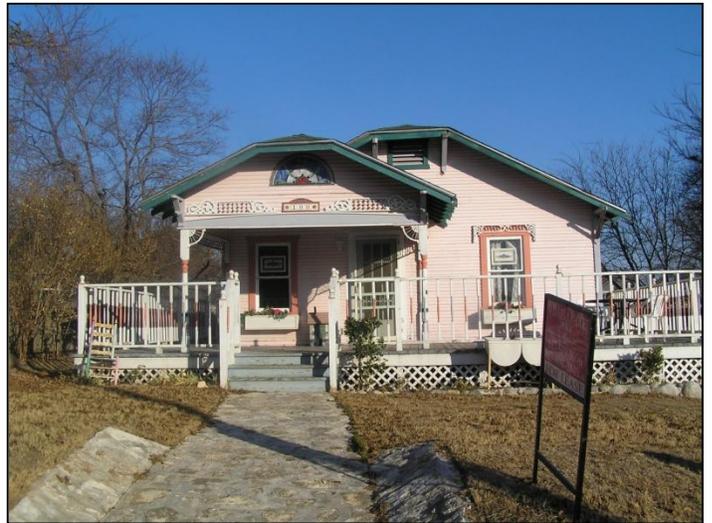
Photo Data: Roll/Frame UP1/17-Up1/18

Areas of Significance (include justification): Inappropriate alterations may be reversible

Location: Original Location

-Building faces west

-Asymmetrical plan

-Pier and Beam foundation

-Drop siding

-Hipped roof porch with fabricated metal supports and turned wood balusters

-Wood sash windows (One over One)

-Single door primary entrance

-Hipped roof with composition shingles
