Site #77

504 E. Bridge

Granbury

Property Type: Vernacular House

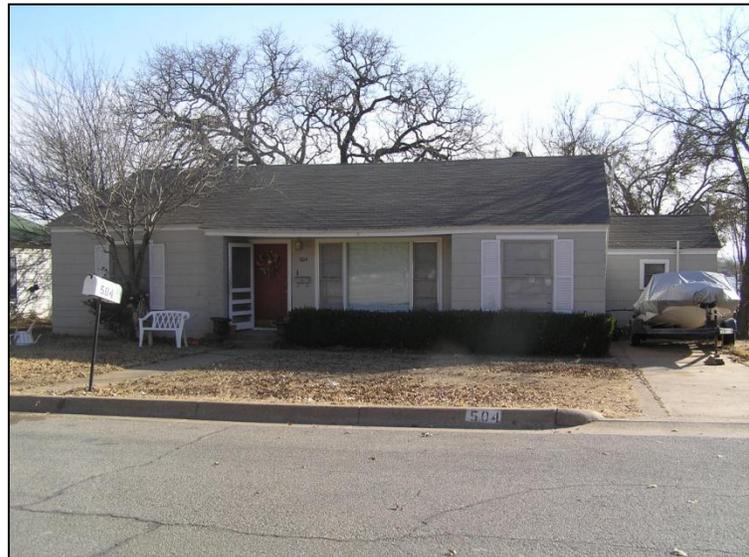
Photo Data: Roll/Frame M2/11

Building faces north

-One story frame structure

-Pier and beam foundation

-Synthetic siding

-One bay, north elevation, inset porch with one brick pilaster and shed roof

-Wood sash, double hung windows (2/2 horizontal) and one large fixed bay window with sidelights

-Single door primary entrance

-Gable end treatments-same as wall surface with vents

-Gable roof with composition shingles and box eaves
