Site #78

510 E. Bridge

Granbury

Property Type: Vernacular House

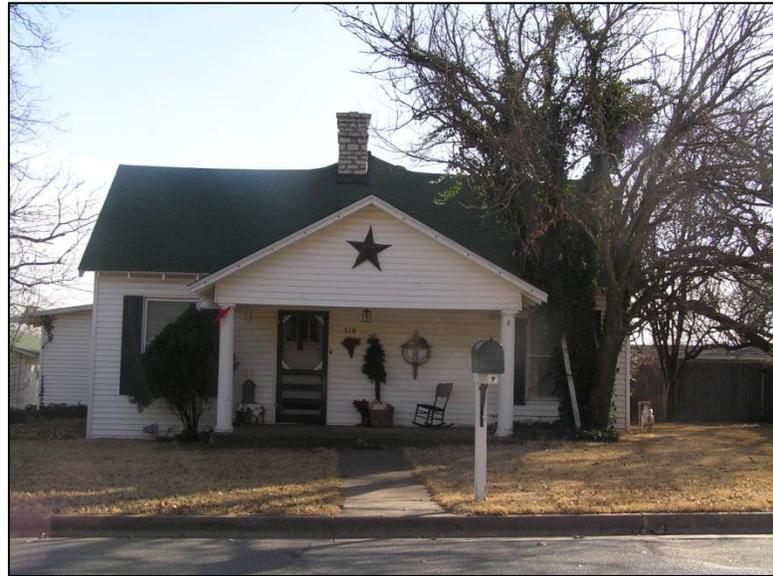
Photo Data: Roll/Frame M2/10

-Building faces north

-One story frame structure

-Asymmetrical plan

-Synthetic siding

-One bay, north elevation porch with classical Doric columns and gable roof

-Wood sash, double hung windows (1/1 & 2/2 horizontal)

-Single door primary entrance

-Gable end treatments-same as wall surface with vents

-Gable roof, Hipped roof (in back section), with composition shingles and exposed rafter ends

-One interior stone chimney with corbelled caps at center of gable roof

Outbuildings: One block and frame garage
