Site #79

**608 E. Bridge**

Granbury  
Hood County  
Est. 1910

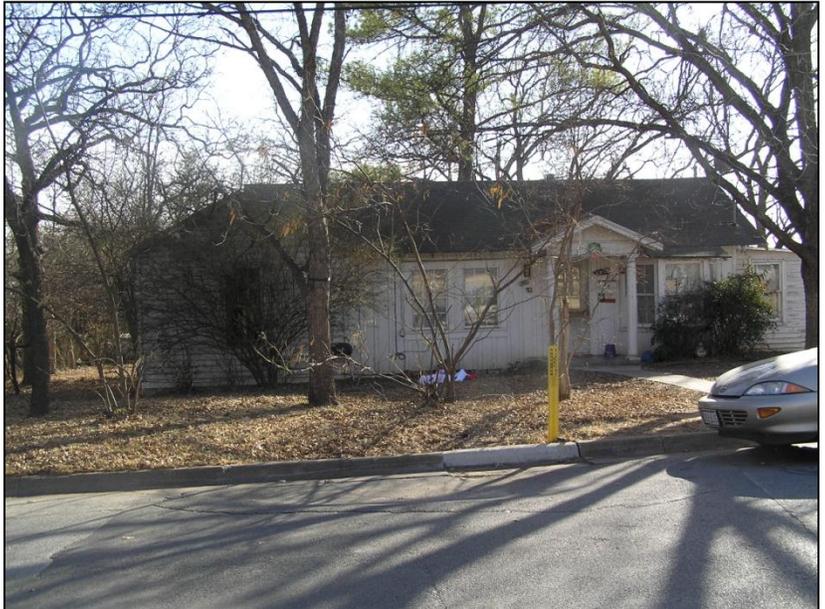
**Photo Data:** Roll/Frame M2/8-  
M2/9

Location: Original Location

-Building faces north

-One story frame structure

-Center passage plan (two rooms deep)

-Pier and beam foundation

-Weatherboard/Board and Batten siding

-One bay, north elevation porch with Doric columns and gable roof

-Wood sash, double hung windows (6/6) and projecting three-window bay on East side of door

-Single door primary entrance

-Gable end treatments-same as wall surface

-Gable roof with composition shingles, box eaves, and exposed rafter ends
