Site #97

503 E. Bridge

Granbury

Stylistic Influence: Craftsman

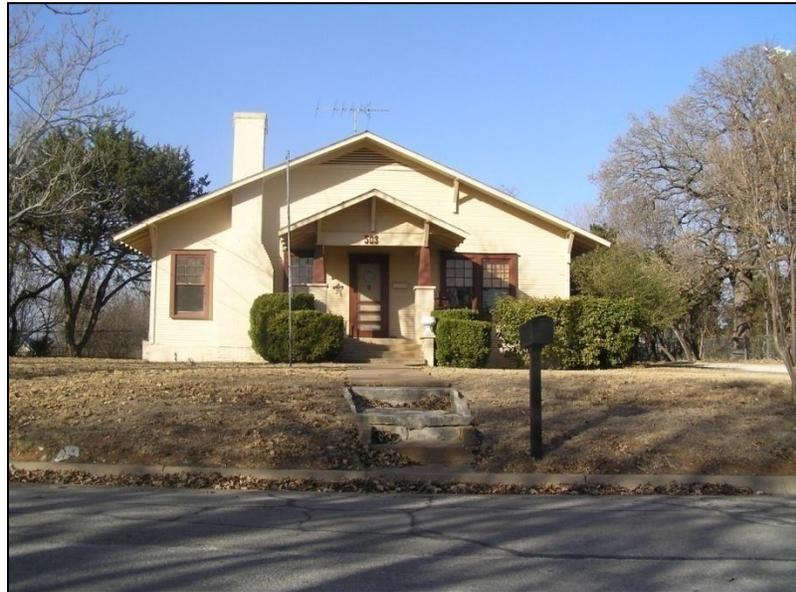
Photo Data: Roll/Frame M1/13

-Building faces south

-One story frame structure

-Bungalow plan

-Pier and beam foundation

-Drop siding

-One bay, south elevation porch with gable roof and tapered box supports on P piers

-Wood sash, double hung windows (9/1)

-Single door primary entrance

-Gable end treatments-same as wall surface with vents

-Gable roof with composition shingles, exposed rafter ends and stick brackets

-One exterior brick chimney placed in front, west of door
