Site #98

Ben Estes House

511 E. Bridge

Granbury

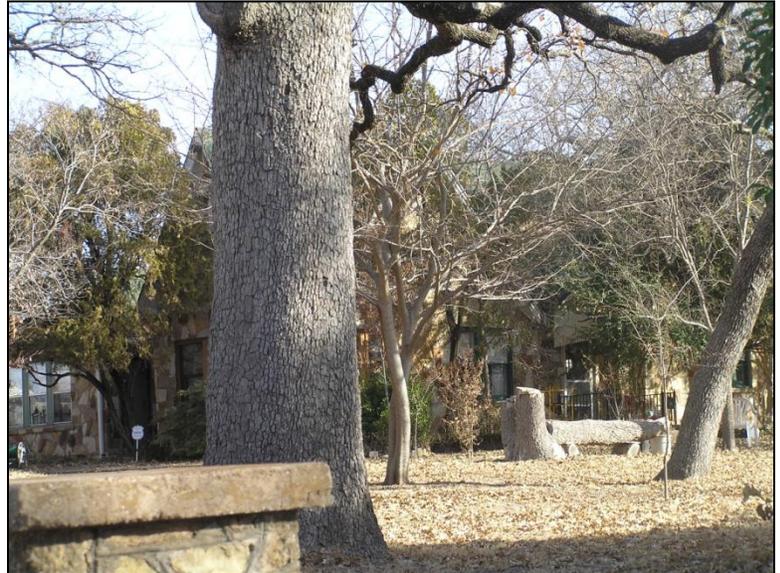
Photo Data: Roll/Frame M1/14

-Building faces south

-Two story stone (fieldstone orange and tan) structure

-Modified L-plan

-Pier and beam foundation

-Exterior wall surface-fieldstone with petrified wood

-Rock arch & pediments surround entry, enclosed porch on east side (arches closed in)

-Wood sash, double hung windows (1/1), leaded glass front triple window

-Single door primary entrance

-Gable end treatments-same as wall surface with decorative bargeboards, vents, and steep gables

-Gable roof with composition shingles and exposed rafter ends

-One exterior stone chimney (west of door)

-Triple-tiered, rocked garden & low rock fence around front of lot
