Site #99

**621 E. Bridge**

Granbury  
Hood County  
Est. 1920

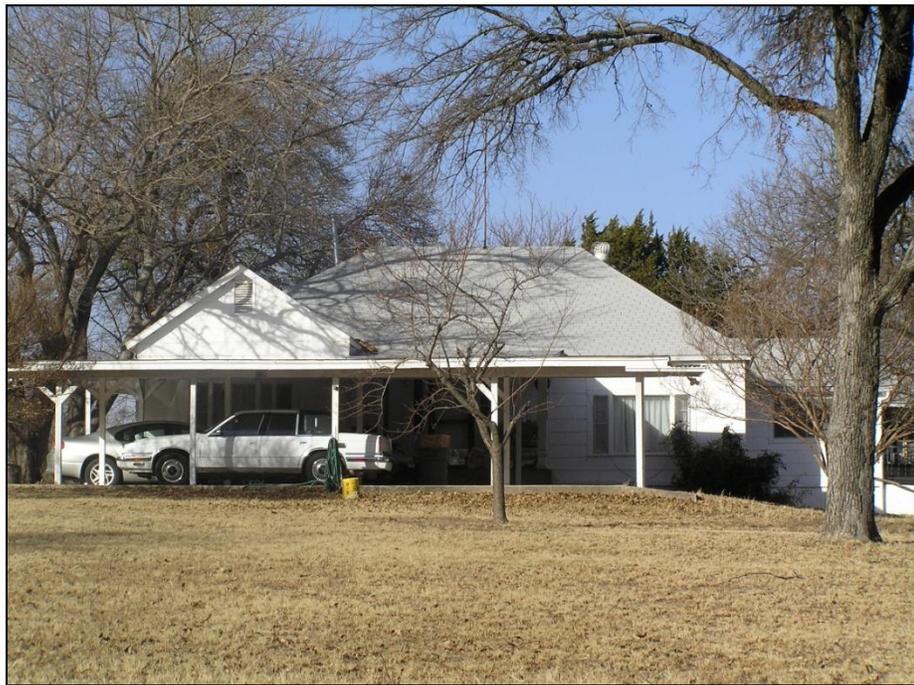
**Photo Data:** Roll/Frame M2/1-  
M2/2

-Building faces south

-One story frame structure

-Center passage plan (two rooms deep)

-Pier and beam foundation

-Synthetic siding

-One bay, south elevation with shed roof and squared posts

-Wood sash, double hung windows (original 2/2), Three fixed, one-panel bays with sidelights-two in front, one in back, and added aluminum casements

-Single door primary entrance

-Gable end treatments- same as wall surface with vents

-Gable/hipped roof with composition shingles

-One interior, center, small metal chimney

**Outbuildings:** Garage added on east side, added carport
