Site #154

503 Counts Alley

Granbury
Hood County
Est. 1910

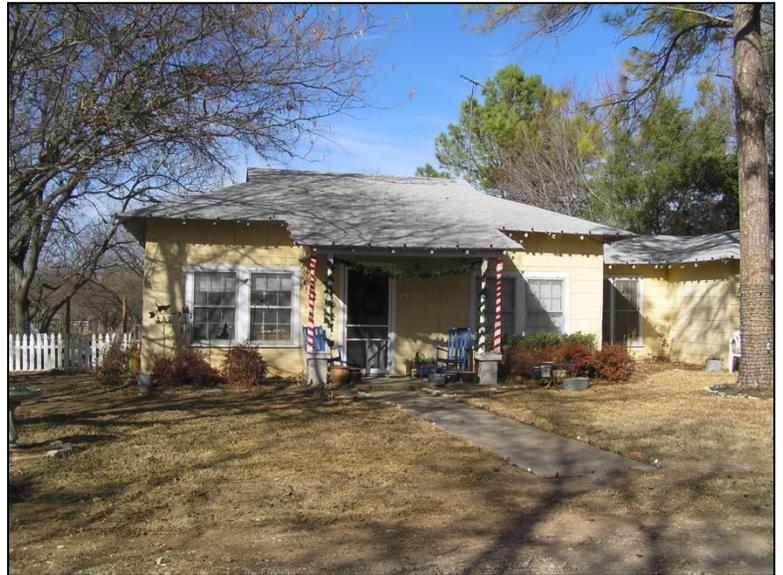
Photo Data: Roll/Frame M4/13

History of Property: Inappropriate siding may be reversible

Location: Original Location

-Building faces south

-One story frame structure

-Center passage plan (two rooms deep)

-Pier and beam foundation

-Asbestos siding

-One bay porch with shed roof and turned wood posts

-Wood sash, double hung windows (6/6)

-Single door primary entrance

-Hipped roof with composition shingles and exposed rafter ends
