**2008 Historic Resource Survey
North Side, City of Granbury**

Property No.: 23
1205 Lipan

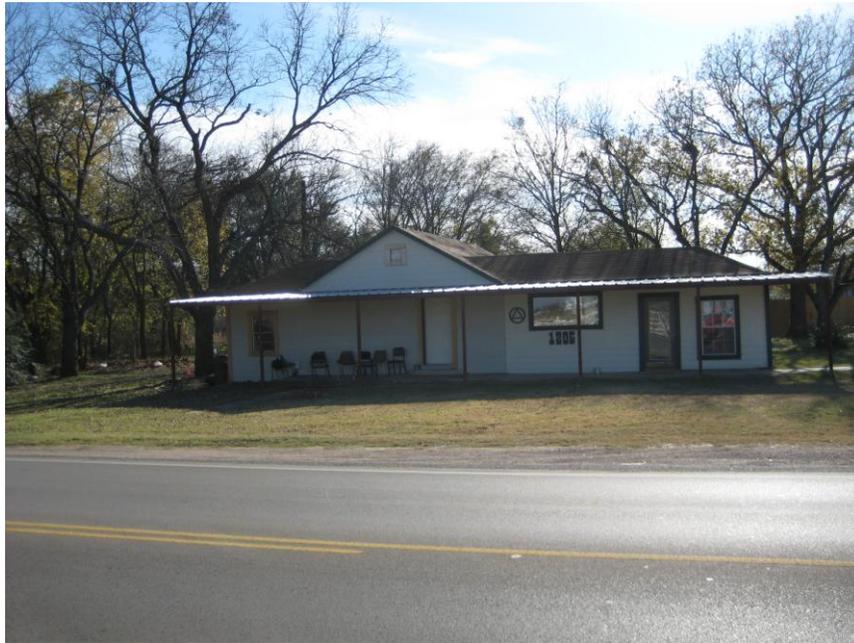
Frame construction, vinyl siding
Hipped roof, composition shingles
Fixed and double-hung, aluminum and vinyl windows
Single-door primary entrance
Metal shed roof porch, wood posts, full-width
Rectangular plan

One story

Building added to and changed extensively, maybe in Appraisal District's database as 1125 Lipan Highway

Location, setting

Development, major alterations, vacancy
