**2008 Historic Resource Survey
North Side, City of Granbury**

Property No.: **75**
727 Lipan

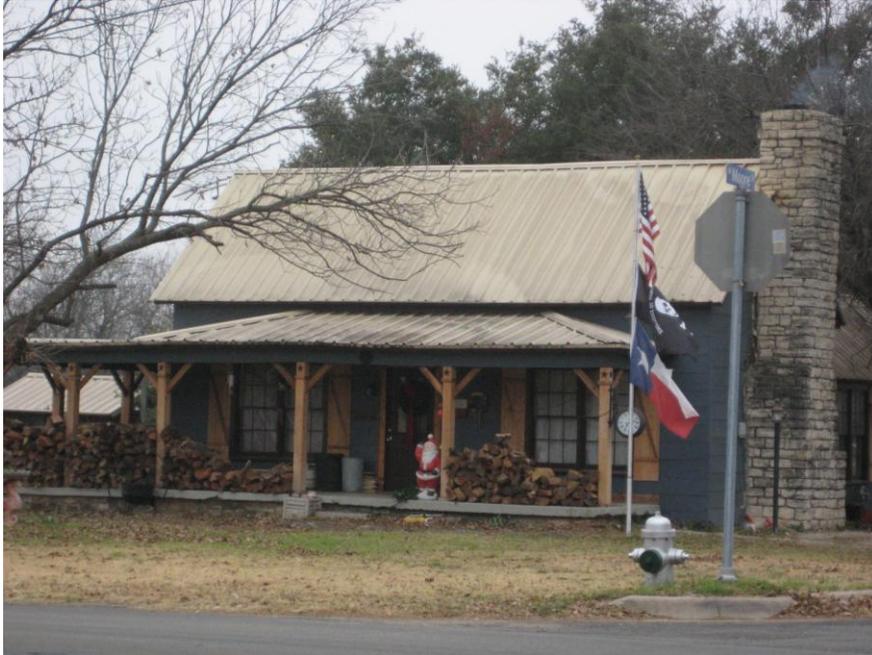
Frame construction, asbestos shingles

Gable roof, metal

One exterior limestone chimney

Double-hung, aluminum windows with added “rustic” decorative wood shutters

Single-door primary entrance

Hipped roof porch, “rustic” wood posts with braces

Pier and beam foundation

Rear ell addition
