2008 Historic Resource Survey
North Side, City of Granbury
Property No.: **156**
720 Stockton

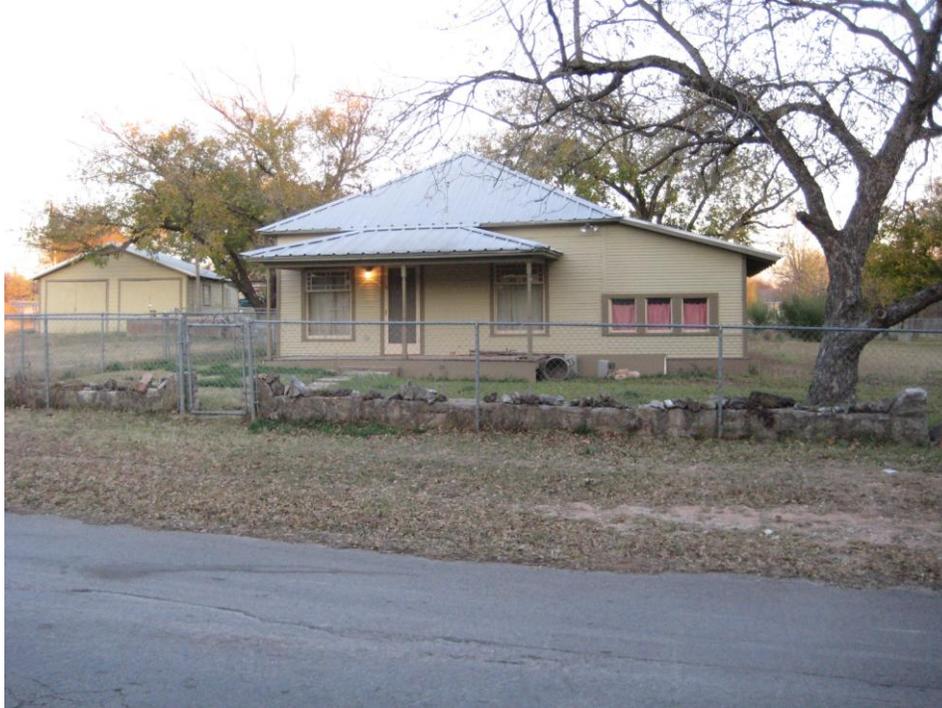
Frame construction, wood siding
Hipped roof, metal, gable dormers
Double-hung wood windows, 1/1, decorative upper pattern
Single door primary entrance
Hipped roof porch with turned wood posts
Four square plan
Pier and beam foundation
One story, 1,192 square feet
Rear shed addition and shed addition on south side with exposed rafter tails and triple horizontal window
Corner lot, chain link fence, low rock walls, petrified wood collection in front yard

Location, design, workmanship, setting, feeling, association
